# Hubbard Brook Phase 1 Stream Geomorphic Assessment Summary

December 11, 2008

**Fitzgerald Environmental Associates, LLC.**

Southern Windsor County  
Regional Planning Commission  
PO Box 320  
Ascutney, VT 05030

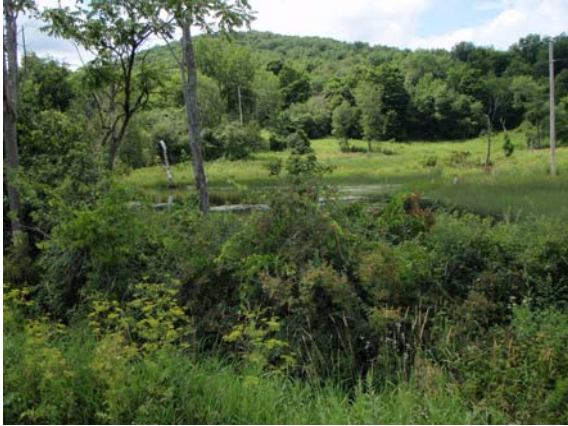
Using aerial imagery, a total of three impoundments were observed in the basin. All three of these features were considered large run-of-the-river because the width of the impounded area was larger than that of the channel. The only flow regulation feature located on the mainstem was found in the headwaters reach M10 where the channel has been backed up to create a pond near a residence. The other impoundments were located on Kimball Brook and Marton Road tributary. The Kimball Brook impoundment, located on reach T1.03, was directly upstream of the Hunt Road crossing and a large area used for grazing cattle (Figure 7). The other impoundment is located in the headwaters of reach T3.01, along side of Pond Road. The correctional facility along State Farm Road has a small water withdrawal used to fill their fire pond (Cueto, 2008). The fire pond was too small to show up on the imagery and no water withdrawal was indexed using FIT, because the exact location is unknown.

**Figure 7.** Impoundment upstream of Hunt Road

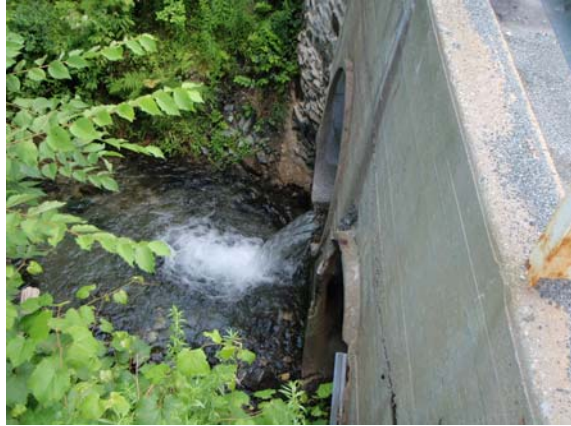
The locations and lengths of bridge and culvert crossings were mapped remotely and were verified in the field where possible. A total of 39 structures were noted on the 20 assessed reaches. Reaches M05, M06, M08, M09, T1.01, and T2.01 had impact ratings of “low,” where at least 5 percent of the channel length is occupied by a bridge or culvert. Reach M05 is intersected by Interstate 91, and had the greatest single impact with approximately 200 feet of the channel piped under the highway in a culvert. Culverts and bridges can also act as a constriction point to the channel at various flow depths, or inhibit the passage of wildlife like the perched culvert observed in reach M07 (Figure 8).

**Figure 8.** Perched culvert at the State Farm Road Crossing

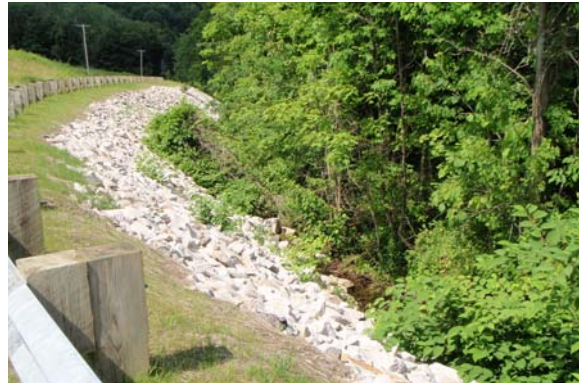
Bank armoring and revetments were noted in as much detail as possible during the windshield surveys. Only one reach had significant amounts of bank armoring. This reach, T2.01 was heavily armored and rip-rapped as part of an effort to stabilize the left bank of the channel where it was encroached upon by the road (Figure 9). In total approximately 1045 feet of the channel bank was stabilized using large boulders piled on a 45° slope to a height of about 25 feet. This effort has significantly affected the natural course of the stream.

**Figure 9.** Rip-rap on the left bank of reach T2.01 along State Farm Road

Sediment load in upper reach is high from the bank failures in T2.01 that have since been addressed by a massive bank armoring effort.

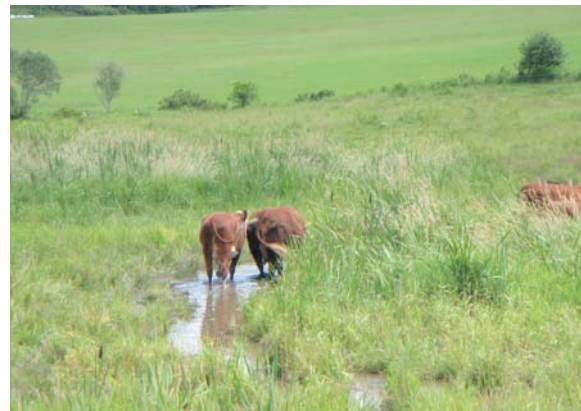
In addition to a high degree of channel straightening in Reach T1.03 (Kimball Brook) this area has been greatly influence by other anthropogenic activities. There, the channelized stream bed has been left open for grazing cattle. Not only does this damage the stream banks, increasing sediment loads, but it acts as a point source for phosphorus and nitrogen pollution (Figure 10).

**Figure 10.** Cows watering in the channel in Kimball Brook reach T1.03

Cows were observed in the channel during the windshield survey. Potential alluvial fan on the upper reach were the slope changes rapidly and the valley widens, near the ponded area.

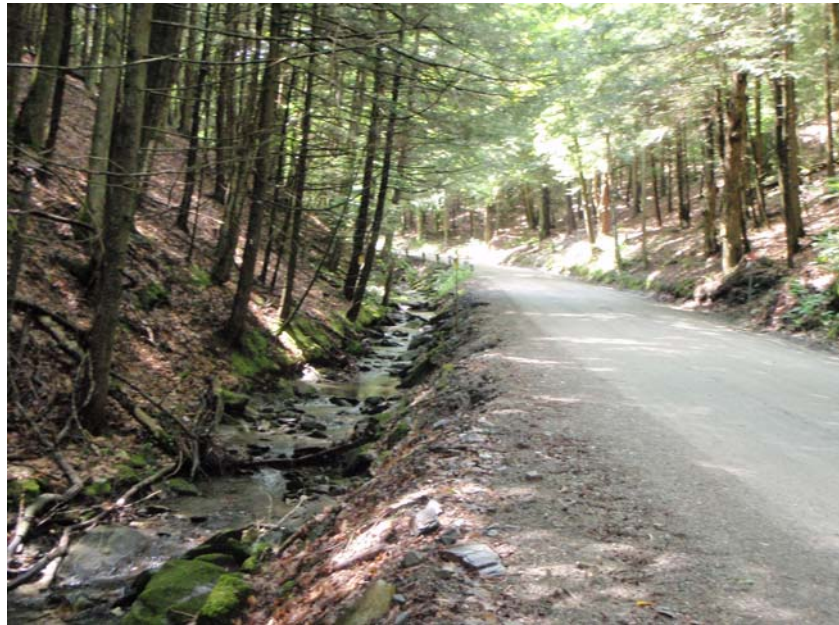
**Figure 12.** Corridor encroachment along Weeden Hill Road in reach M09

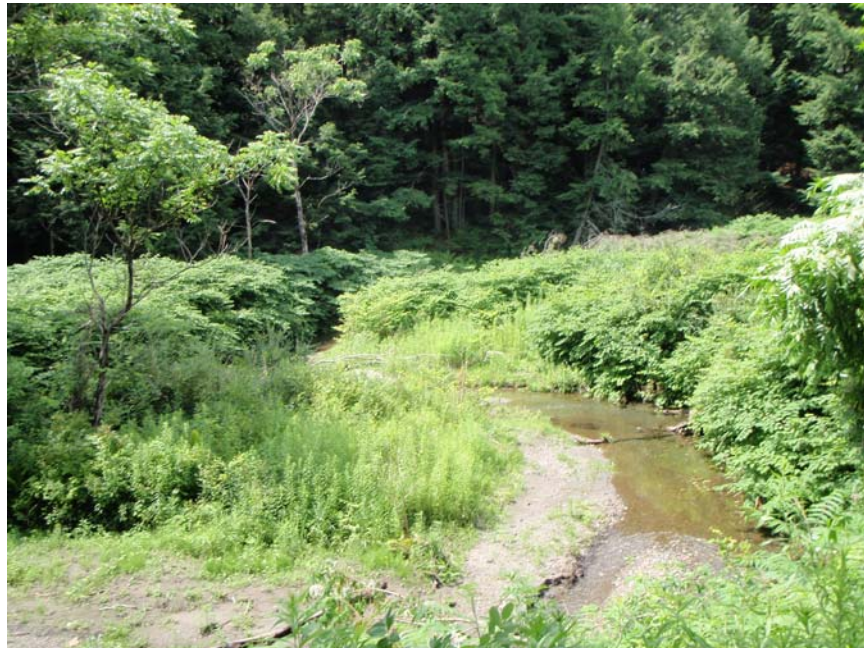
**Figure 13.** High degree of deposition on the point bars of reach M04

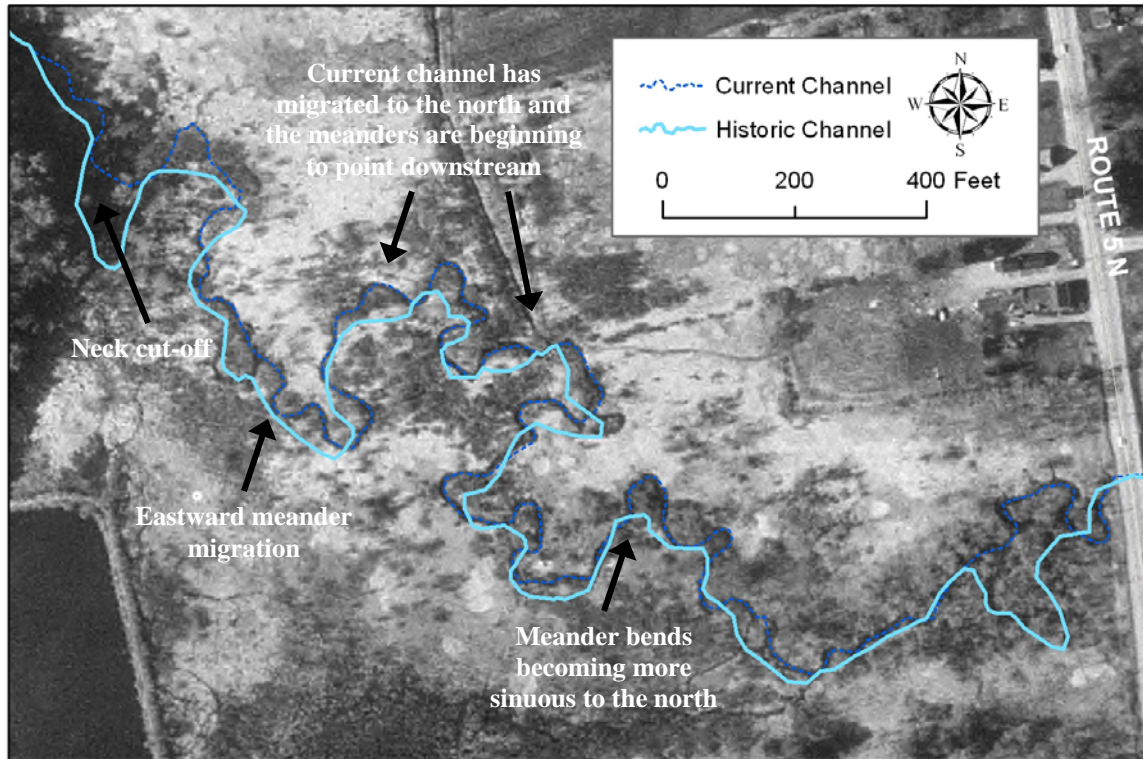
Recent and historic aerial photographs and imagery were reviewed to identify areas of channel migration, bifurcation, and avulsions on the Hubbard Brook mainstem and its tributaries. Historical photographs from 1963 were reviewed. For areas where significant channel migration was noted, the historical imagery was georectified using ArcGIS software to transform the mapping into the NAD 1983 State Plane Meter projections. Previous channel locations (1963) were compared with the Vermont Hydrography Dataset stream centerlines developed from the aerial photographs taken in 1994 for the watershed. M01 showed a dramatic change in planform with extensive meander

migration. Some of the geomorphic changes that have occurred over the last 40 years are highlighted in Figure 14.

**Figure 14.** The changes in channel planform from 1963 to 1994 on reach M01
