Town of Reading Road Erosion Inventory 2016

Completed by Southern Windsor County Regional Planning Commission and the Town of Reading

Fieldwork completed June/ July 2016
Report last revised December 12, 2016

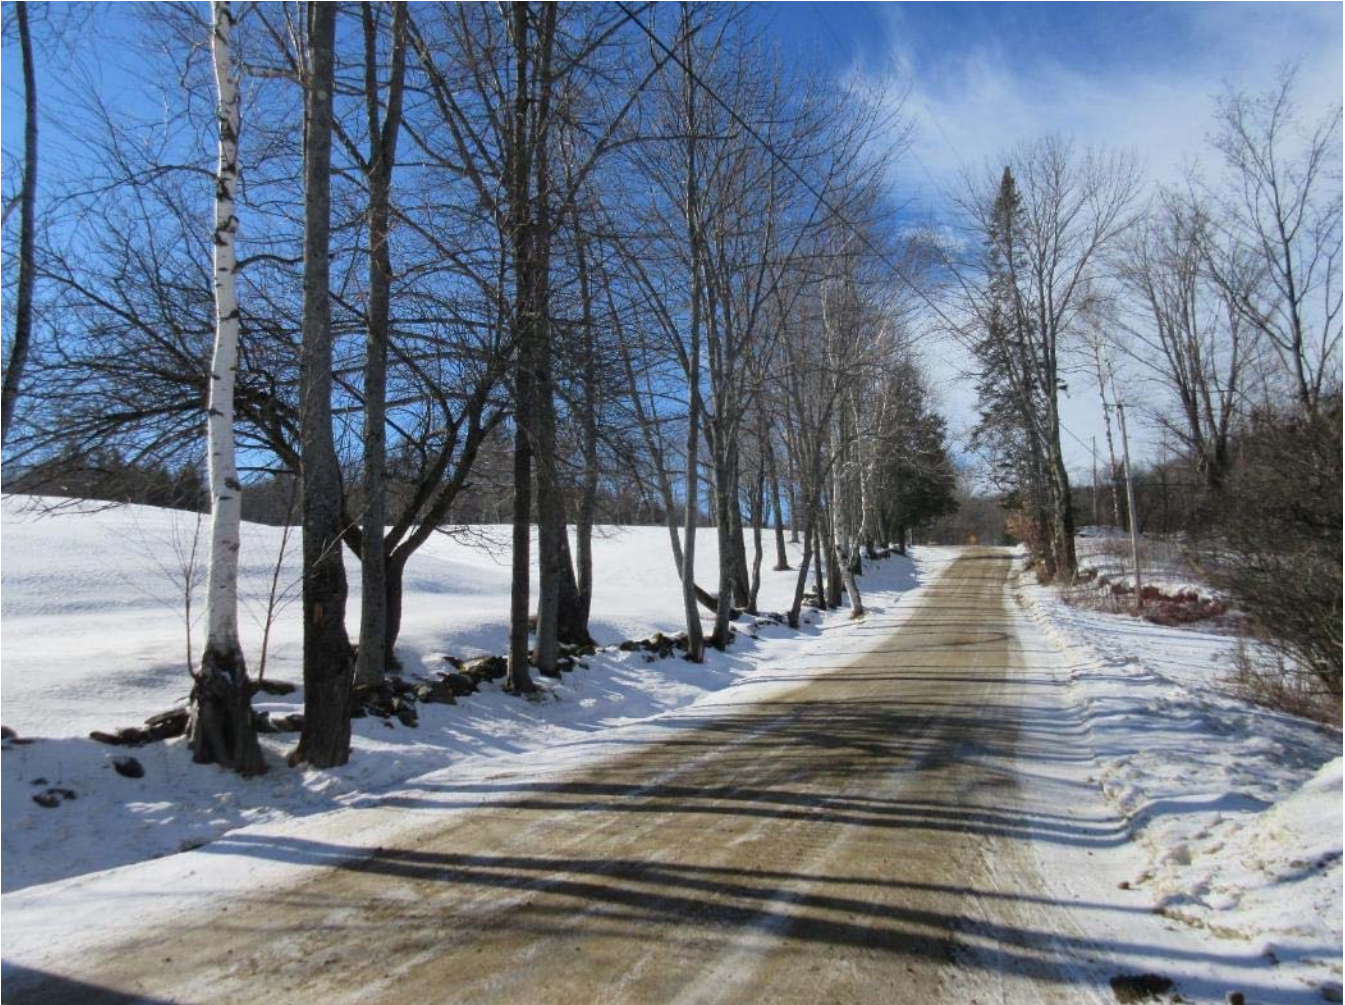
Top: Existing ditch where the ditch improvements would start. Photographer is standing at the site where the “Town Hill Road Culverts project” would start.

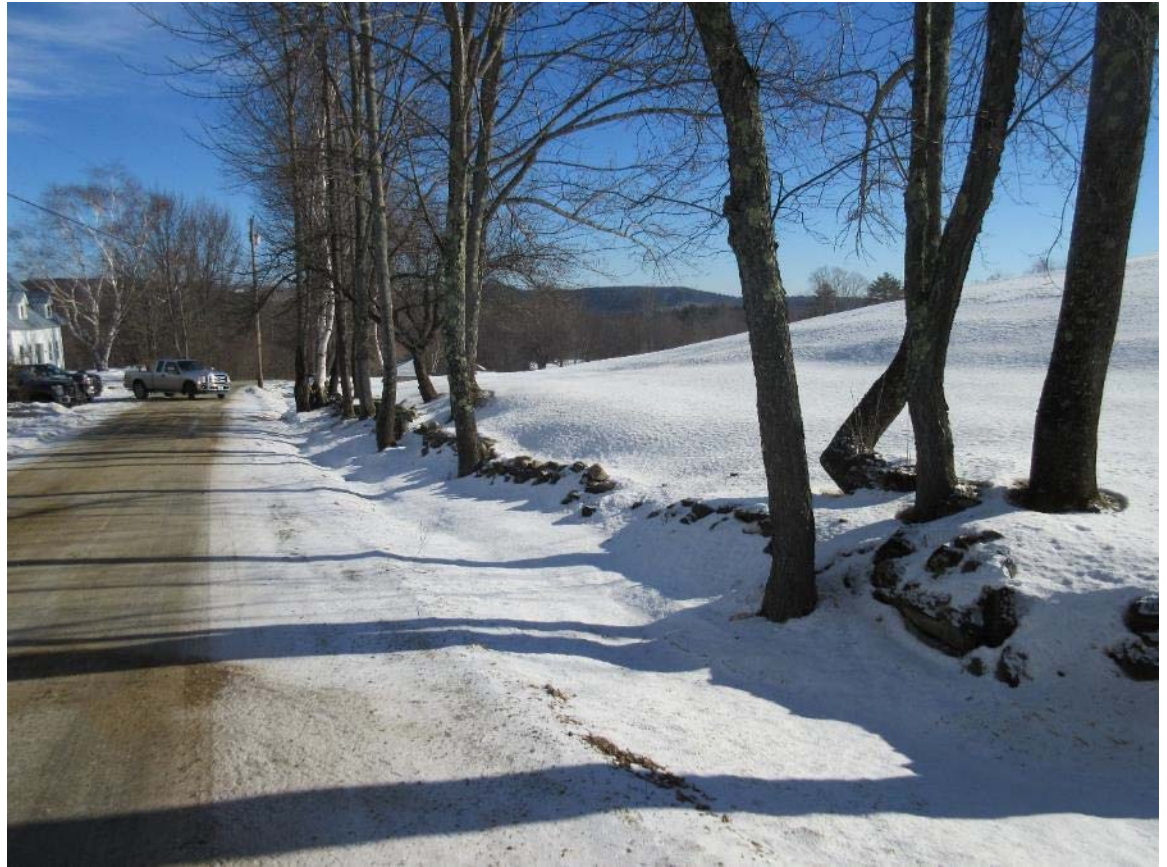
Bottom: Gullying on ditches further downhill from culvert site

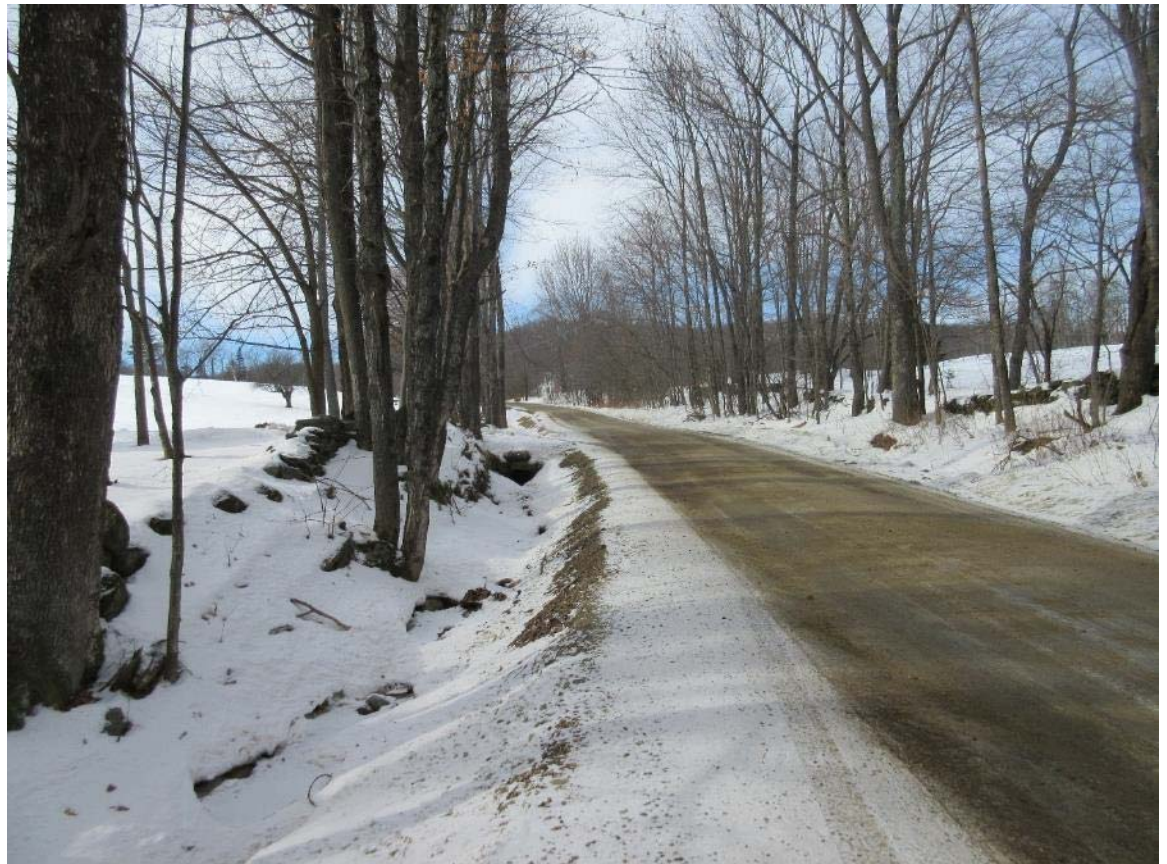
Top left and right: Gullying begins along road

Bottom: Place where ditch turns out to the right into forest. In high water flow water also flows along roadway which turns to the left

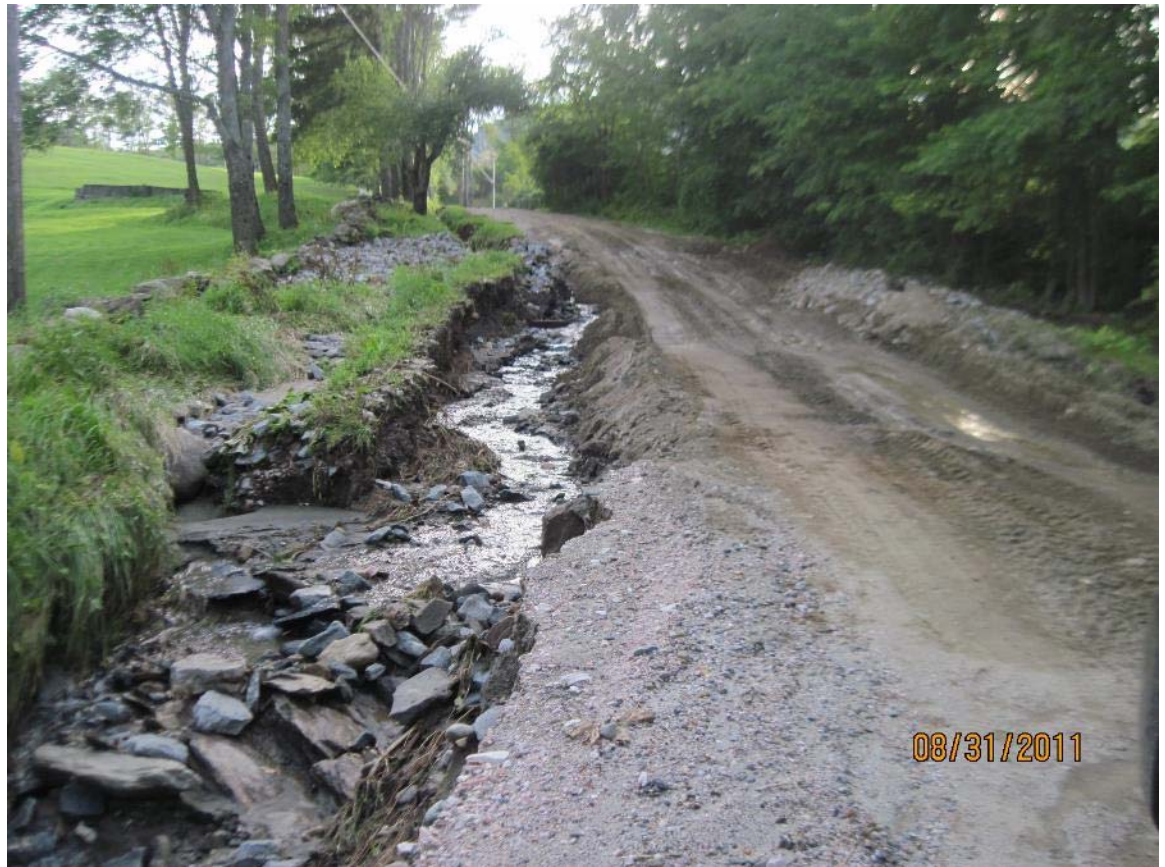
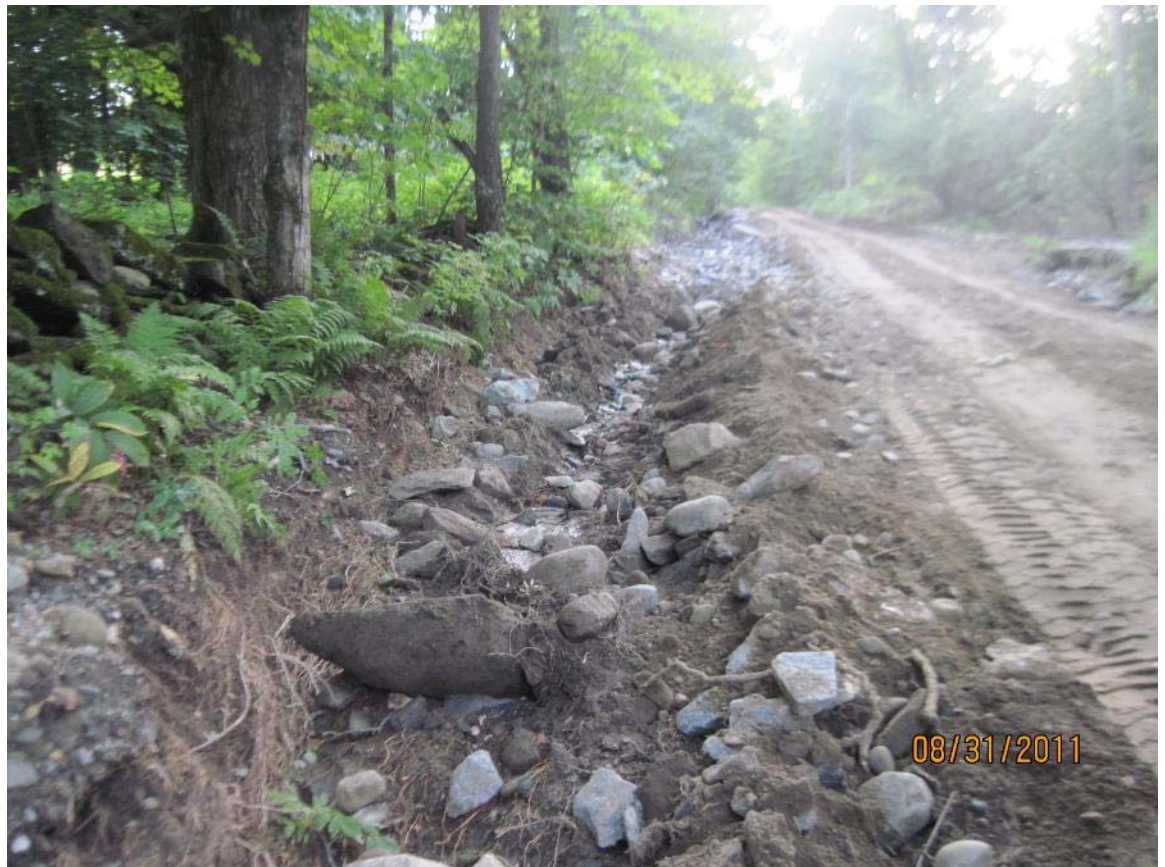
Top and Bottom:
Examples of how
the road washes
out after major
storms. This road
section was
completely washed
out in heavy rains in
2009 and 2011, and
some portions in
2012 and 2014.

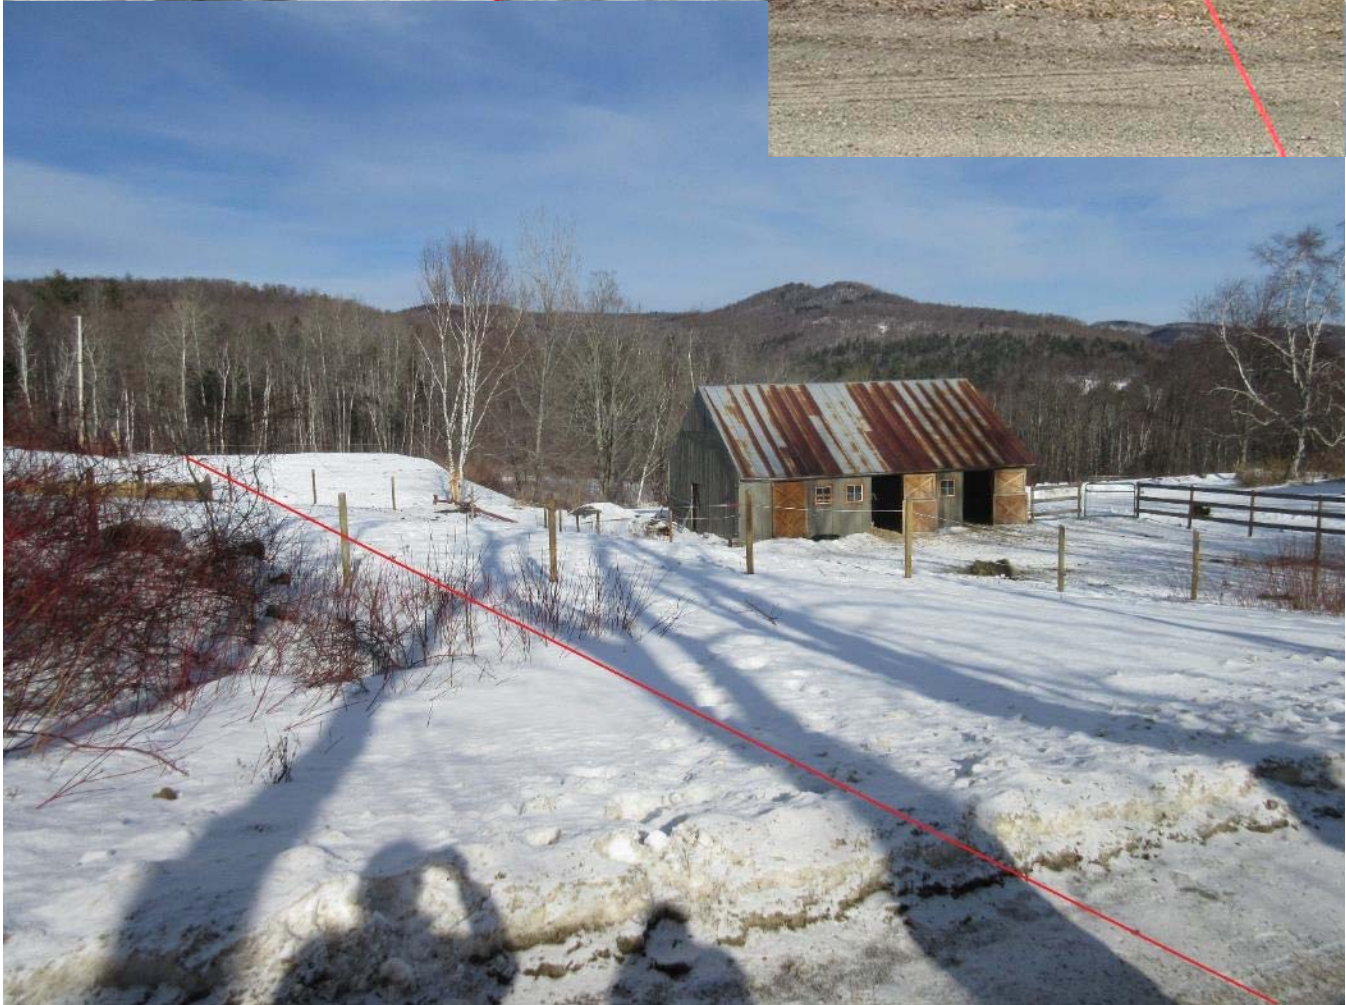
Top: Looking from end of proposed long culvert back to the road (red line shows approximate location of culvert)

Bottom: Existing swale where the culvert will dump into.

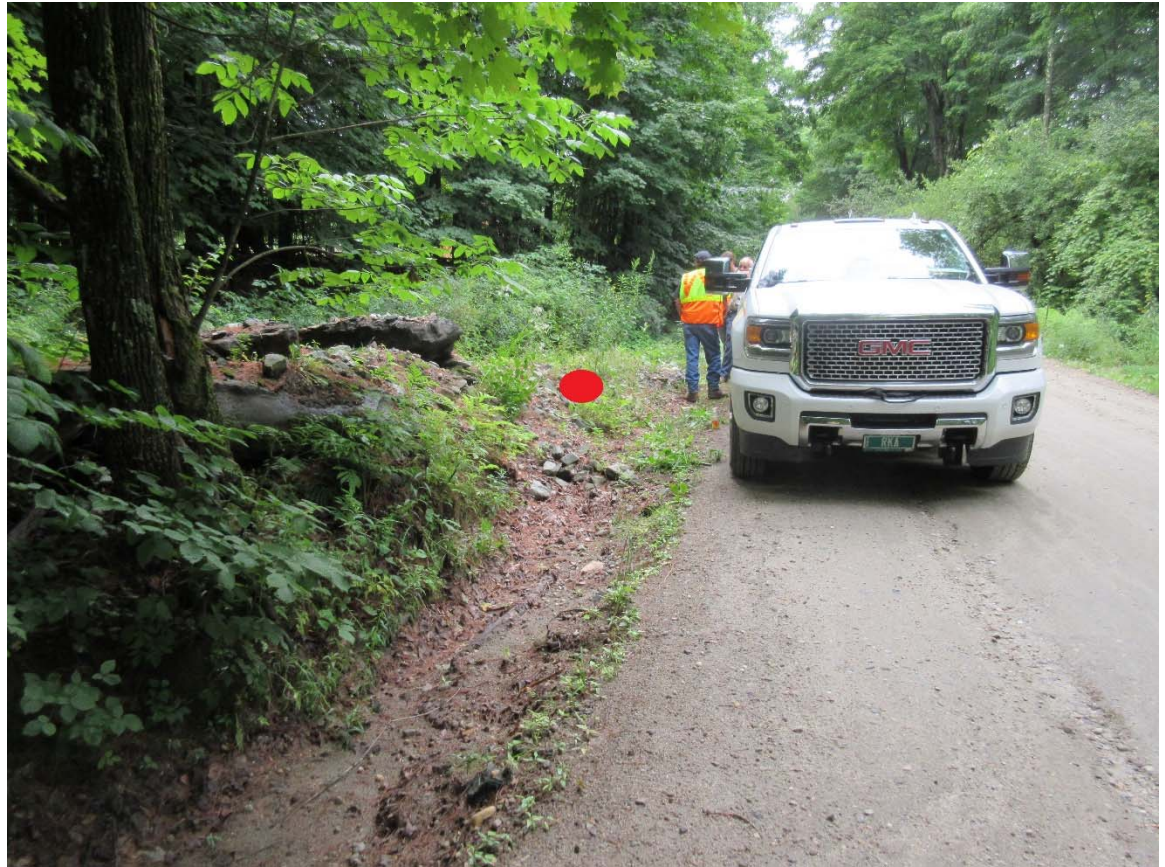
Top left: Red dot shows the approximate location for the overflow culvert coming out of the sediment pond. See Site A for photographs of existing site.

Bottom right: Looking slightly further down the stone lined ditch. The turn out would be approximately where the yellow dot is.

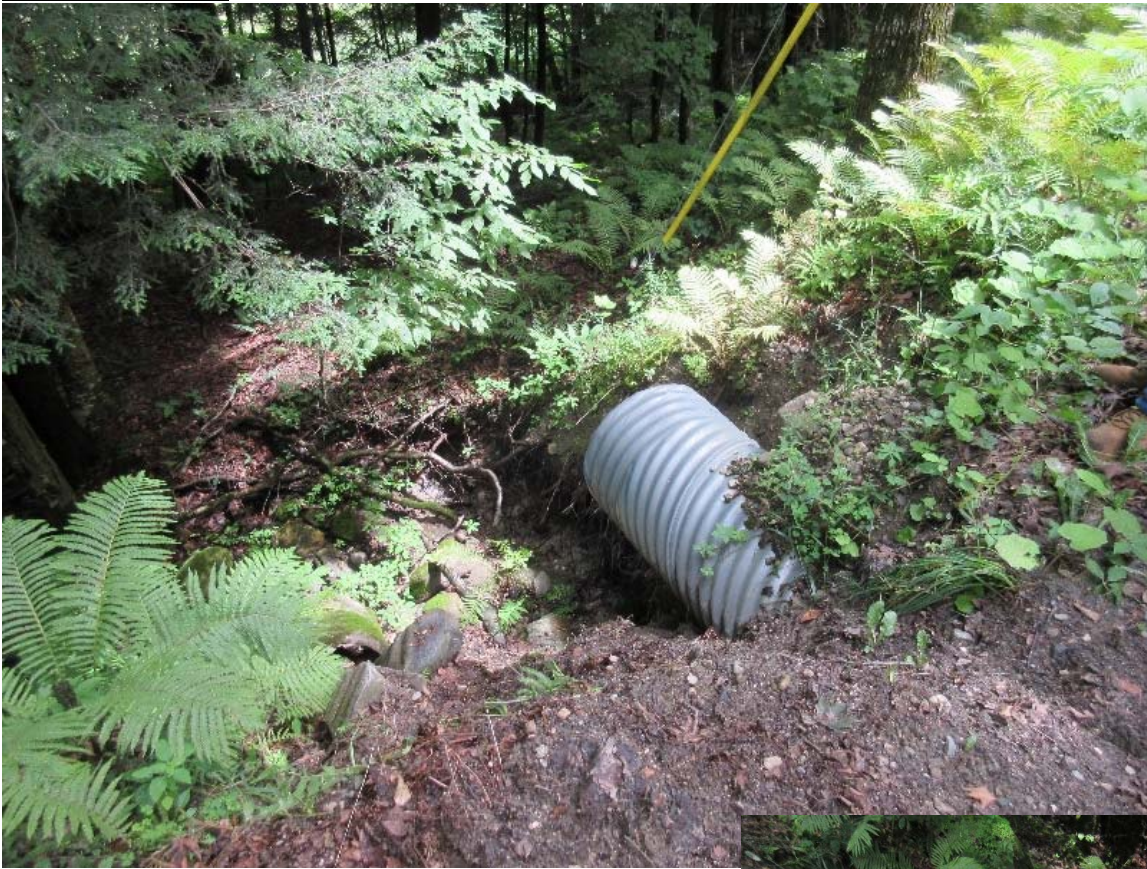
This is an issue that was created in Tropical Storm Irene – this small section of Town Hill Road was not damaged severely like the remainder of the roadway, but the gullyng was caused by the excessive water during the event.

Top left and bottom left: Road material flowing into stream next to culvert

Top right: Side view of road material flowing over side of river into culvert

Bottom right: Ditch on other side of road

- Existing culvert would remain in place since it is good condition
- Build up slope with stone and toe-in the base
- Add a small berm around the top of the slope where the culvert is to stop water flowing straight over side into the water.
- Maybe add a cement lined footer if needed

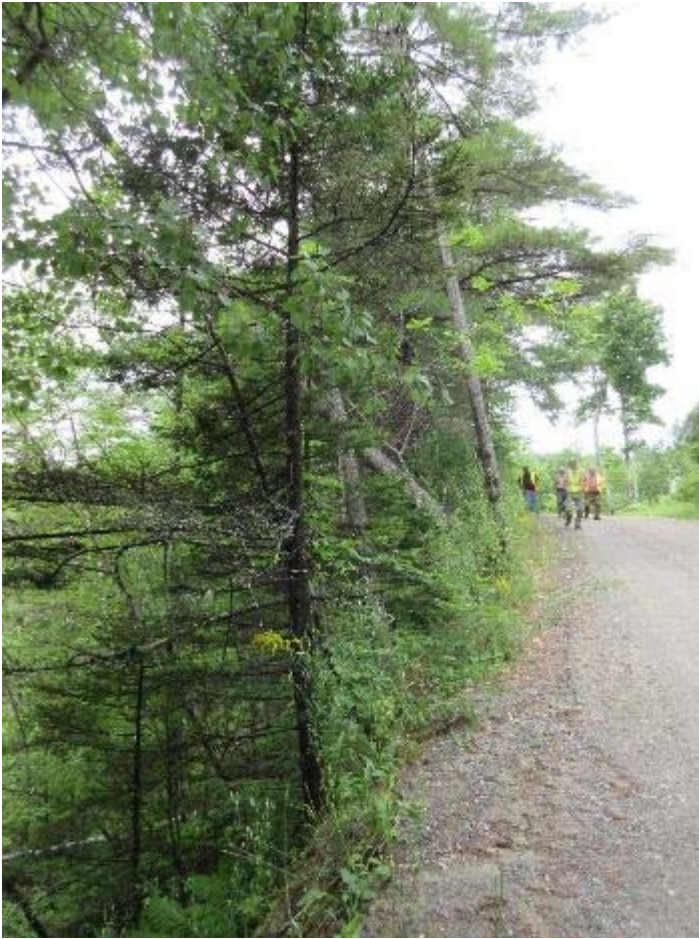
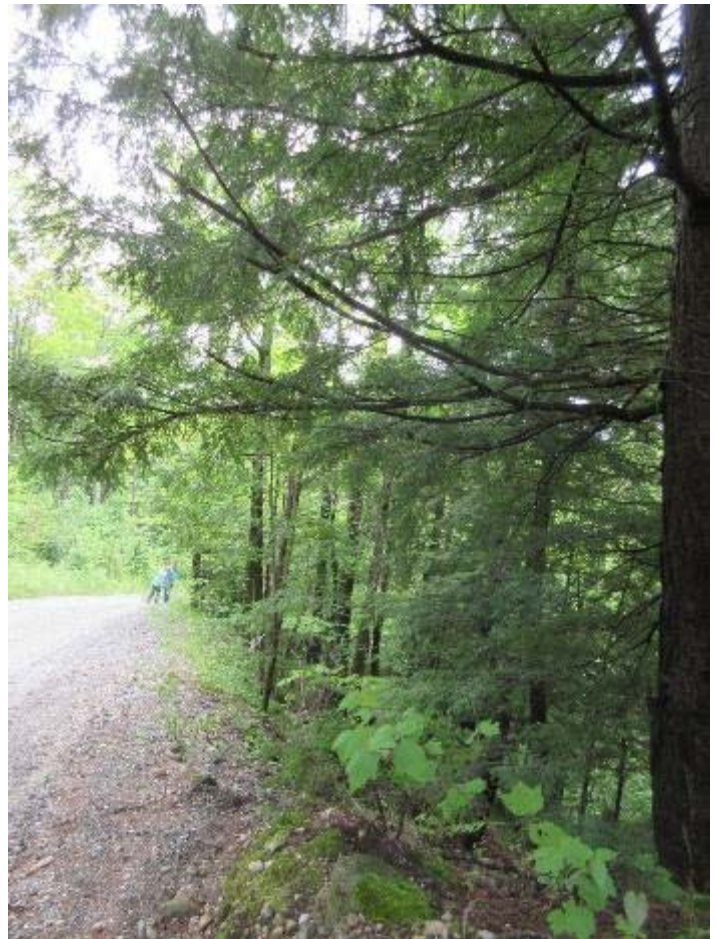
According to the 2015 Mill Brook River Corridor Plan, “a 80ft tall mass failure is close to threatening Kittridge Pasture Road. It is not possible to stabilize the valley wall, therefore the road should be monitored and potentially moved east if necessary” (page 131).

Left: Looking uphill along road. Stream is considerably below the roadway at the base of the steep slope
Right: Looking downhill

The 2015 Mill Brook River Corridor Plan suggests “monitoring the mass failure and moving the road if necessary” (page 131). Engineering would be required to determine the solution and costs if the bank destabilizes again.

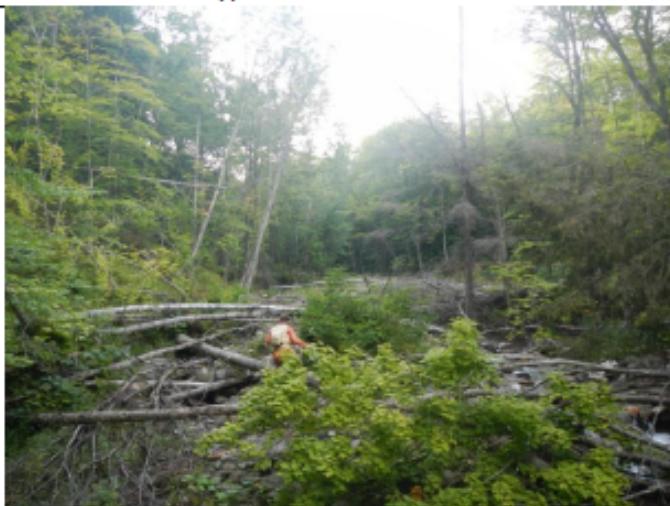
LWD and huge gravel deposits

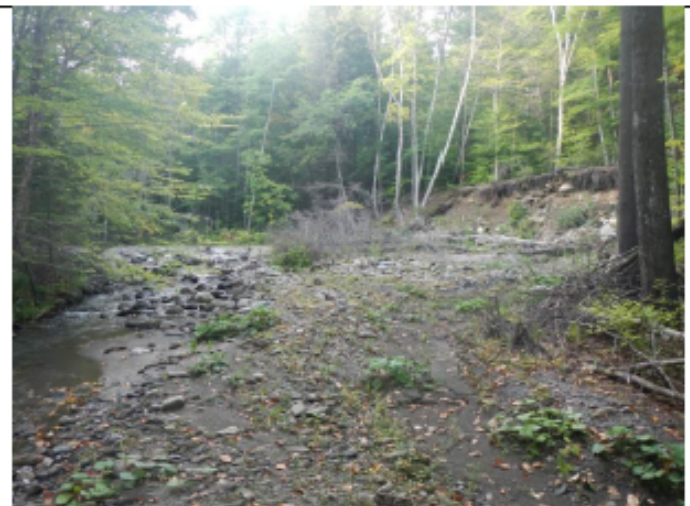
Ongoing widening and erosion/mass failure

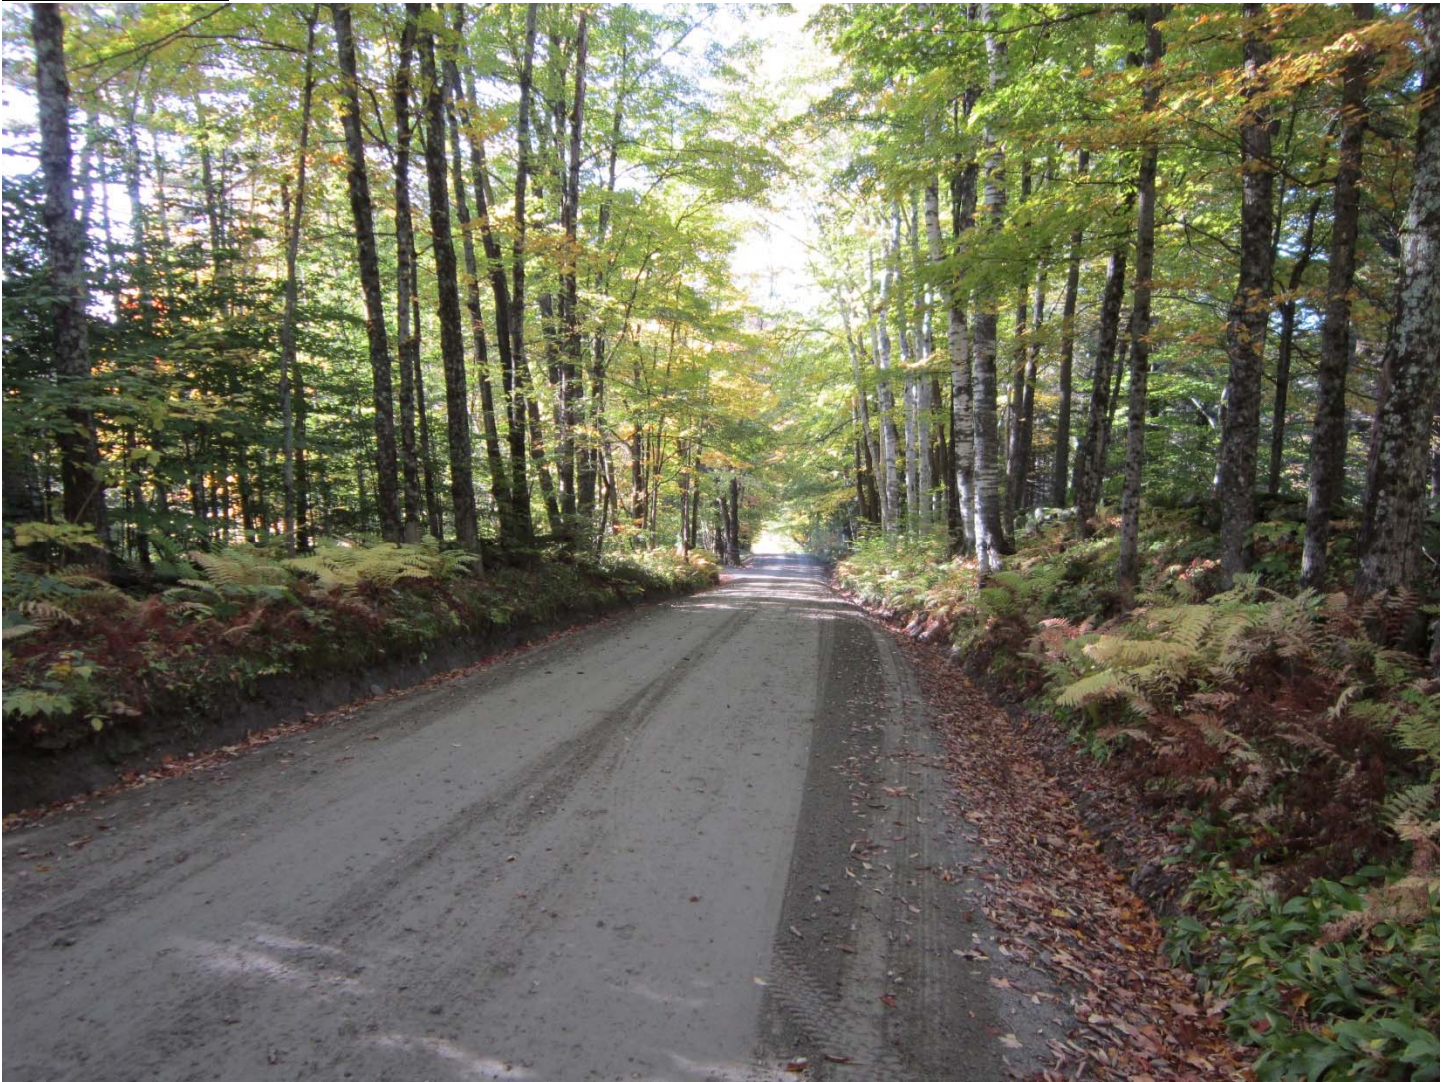
Top: Looking down the hill from the top of the site. Ditch to be stone lined is on the right side of the photograph. A stone lined ditch already exists on the left side of the photograph just beyond the small embankment and continues to the bottom of the hill.

Bottom left: The turn out at the bottom of the site.

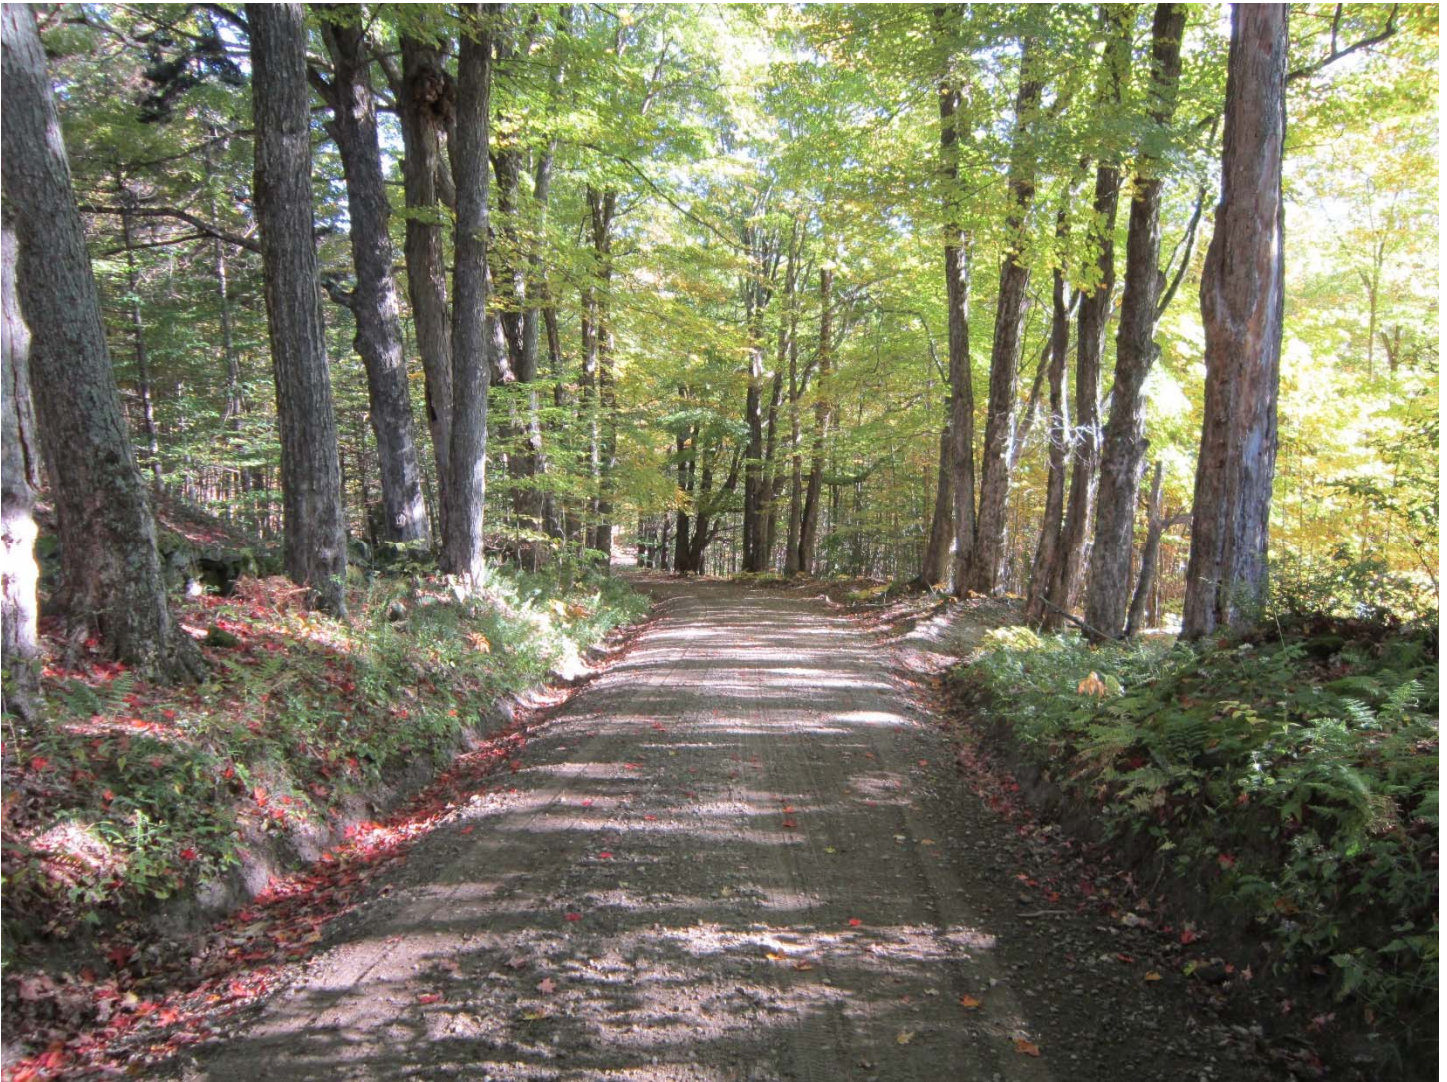
Top: Site from halfway down hill. Existing turnouts on east side of road (right side of photograph). Left side needs improved ditching.

Bottom Left: Looking up hill just above where site would start

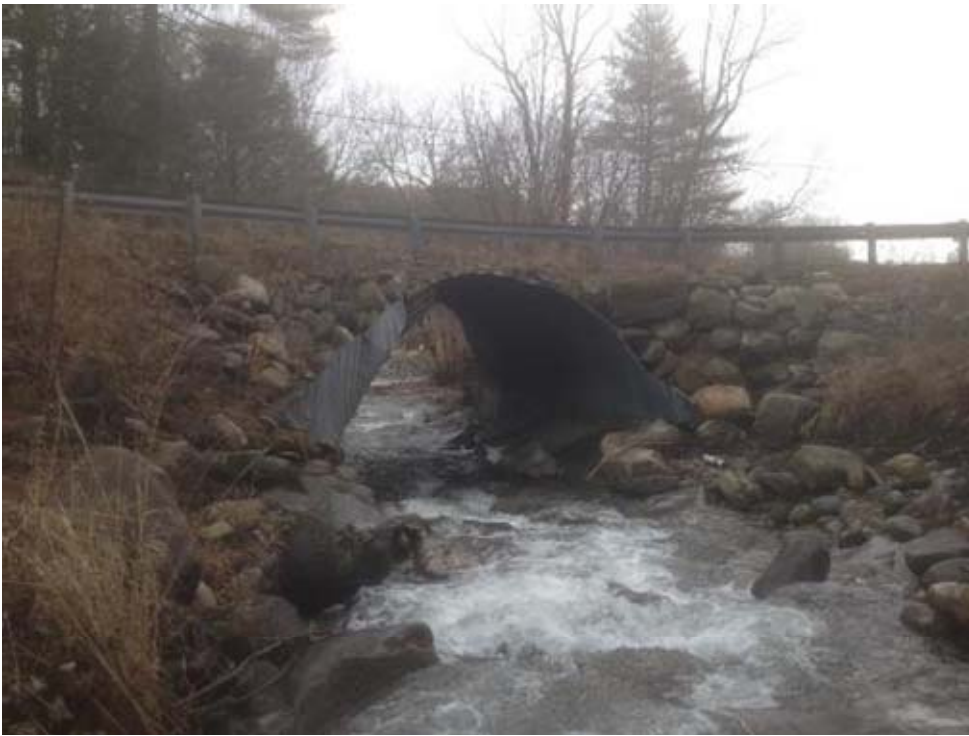
Top: Upstream end of culvert

Bottom: Stream out of equilibrium upstream from the undersized culvert. Majority of the debris and damage due to heavy water flows during Tropical Storm Irene.

- Increase size of culvert/ install a bridge.
- The Town would like to see the downstream Agony Hill Road Culvert upsized before they resolve this issue – otherwise the increased water flow during high-water events would cause issues there instead.

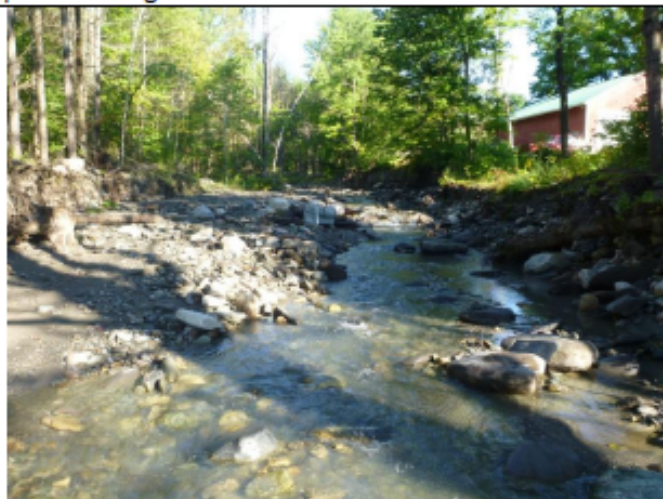
Widening, deposition, and severe erosion

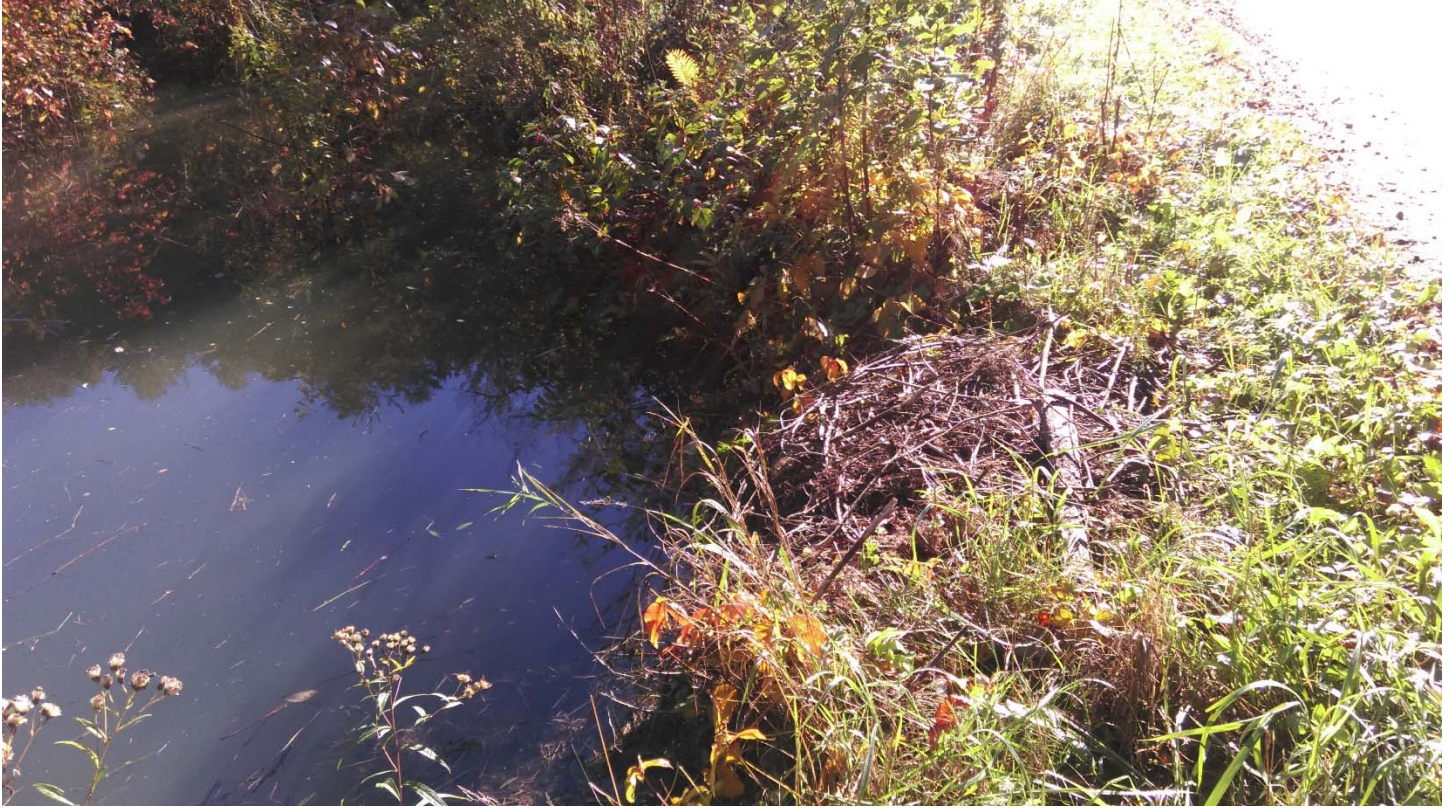
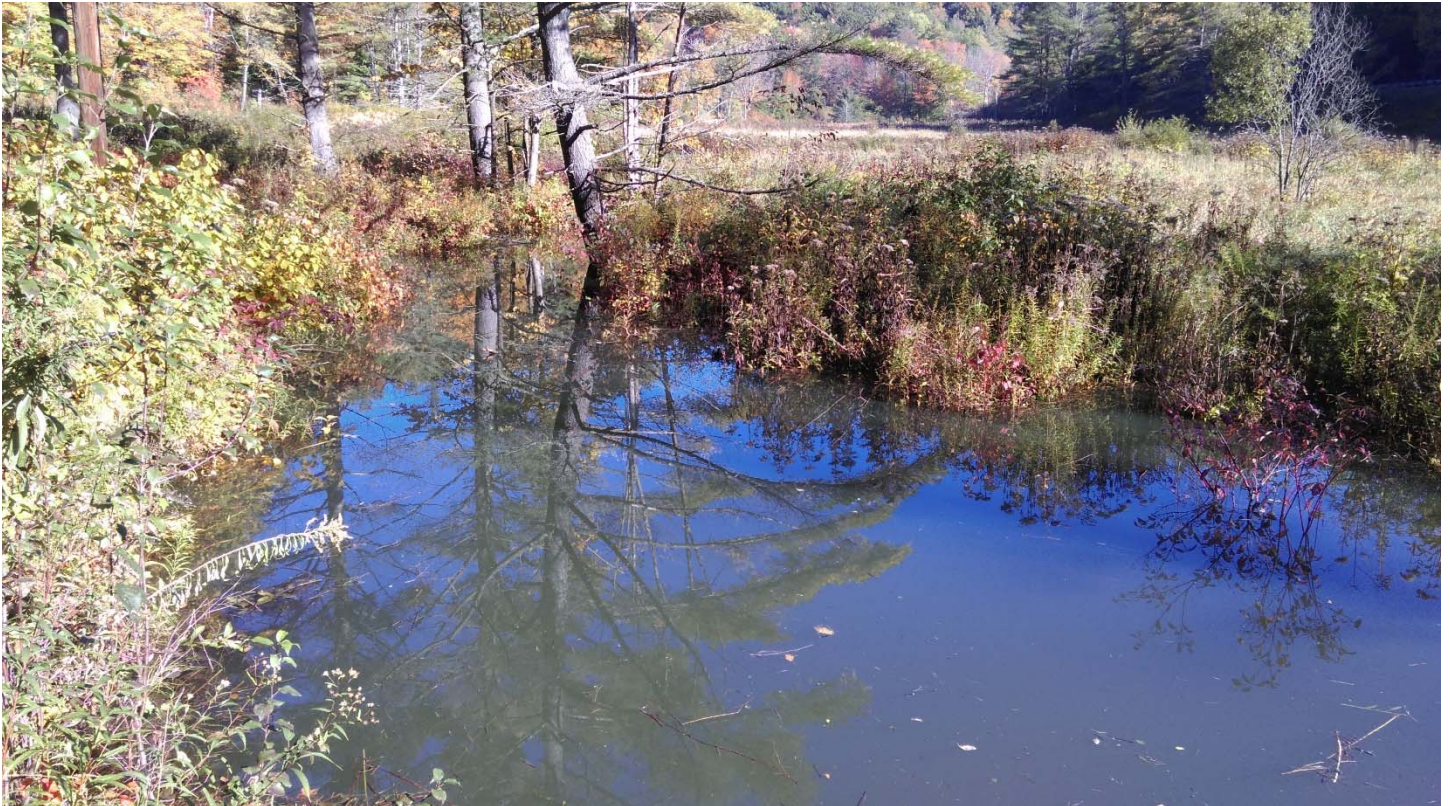
Top: Beaver dam blocking the culvert entrance with water trapped in adjacent wetland.

Bottom: Water trapped in adjacent wetland upstream from culvert blocked by beaver dam.

According to the 2015 Mill Brook River Corridor Plan, the culvert should be “replaced with a larger structure designed to be geomorphically compatible with the stream dimensions” (page 127). This would “improve sediment and floodwater conveyance and reduce sediment inputs to channel” (page 127). Until the beaver issue is mitigated, increasing the size of the structure would probably not help.

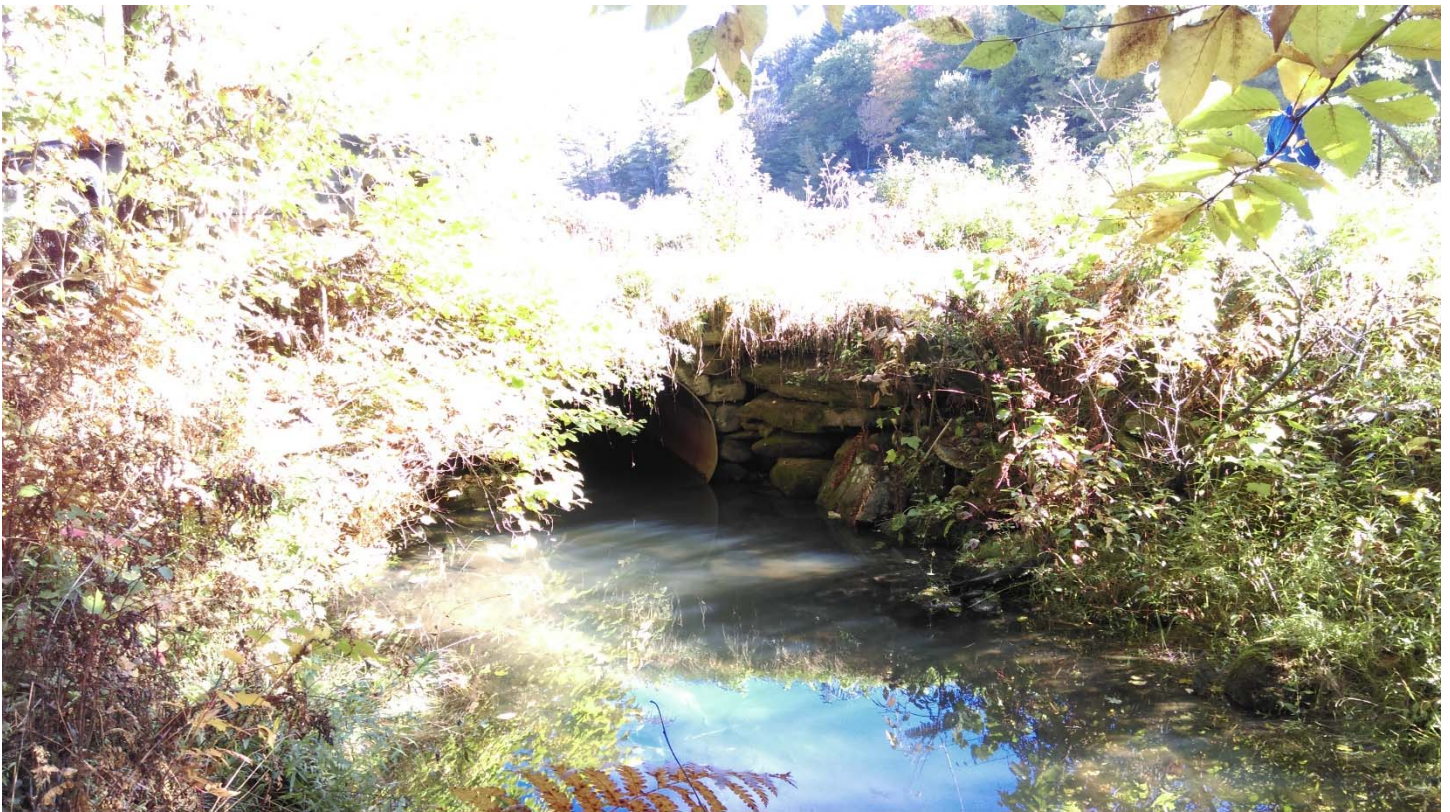
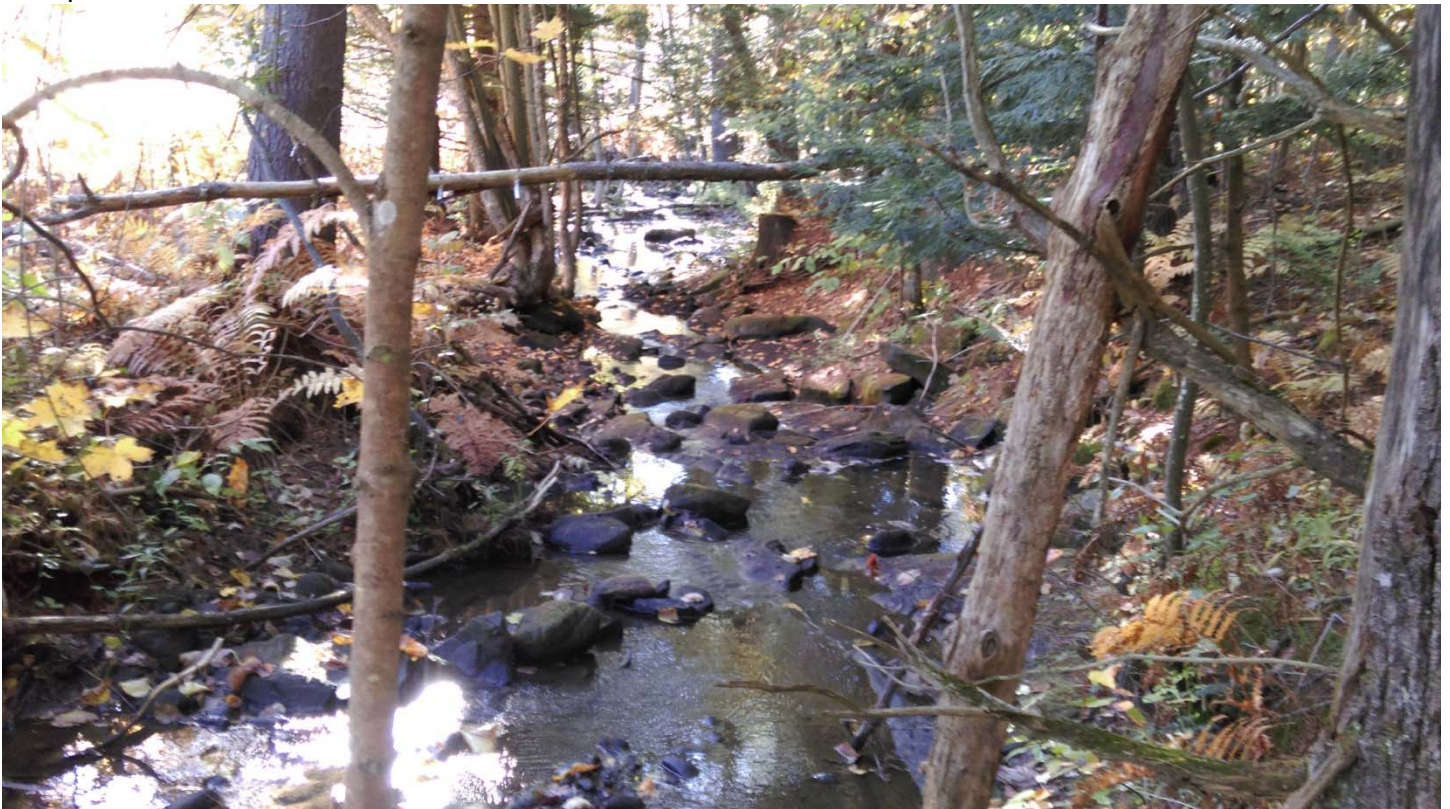
Top: Culvert outlet at the same time that beaver dam blocks inlet
Bottom: Downstream from culvert showing a much narrower stream beyond the influence of previous beaver dam ponds.

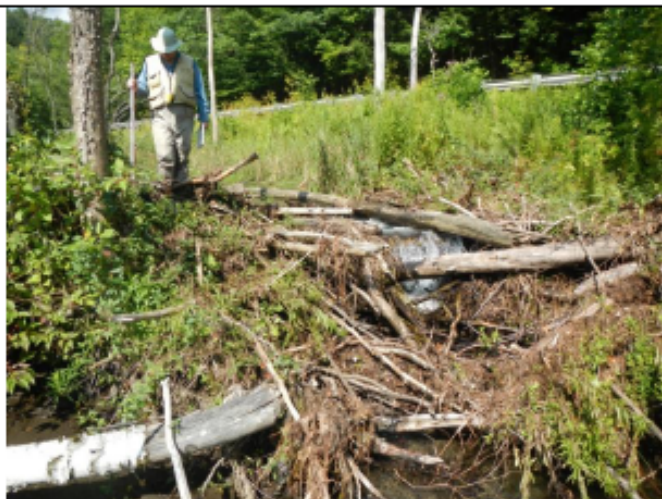
Large beaver dam in upper reach

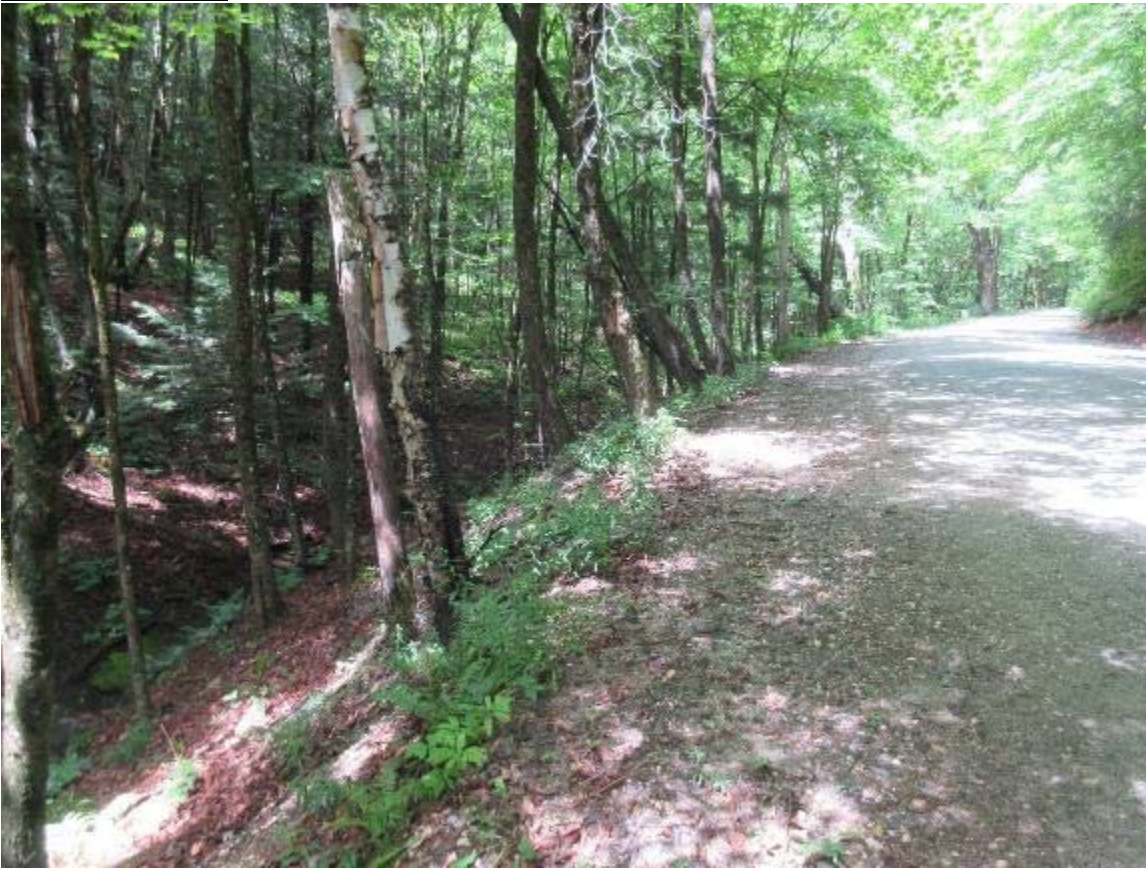
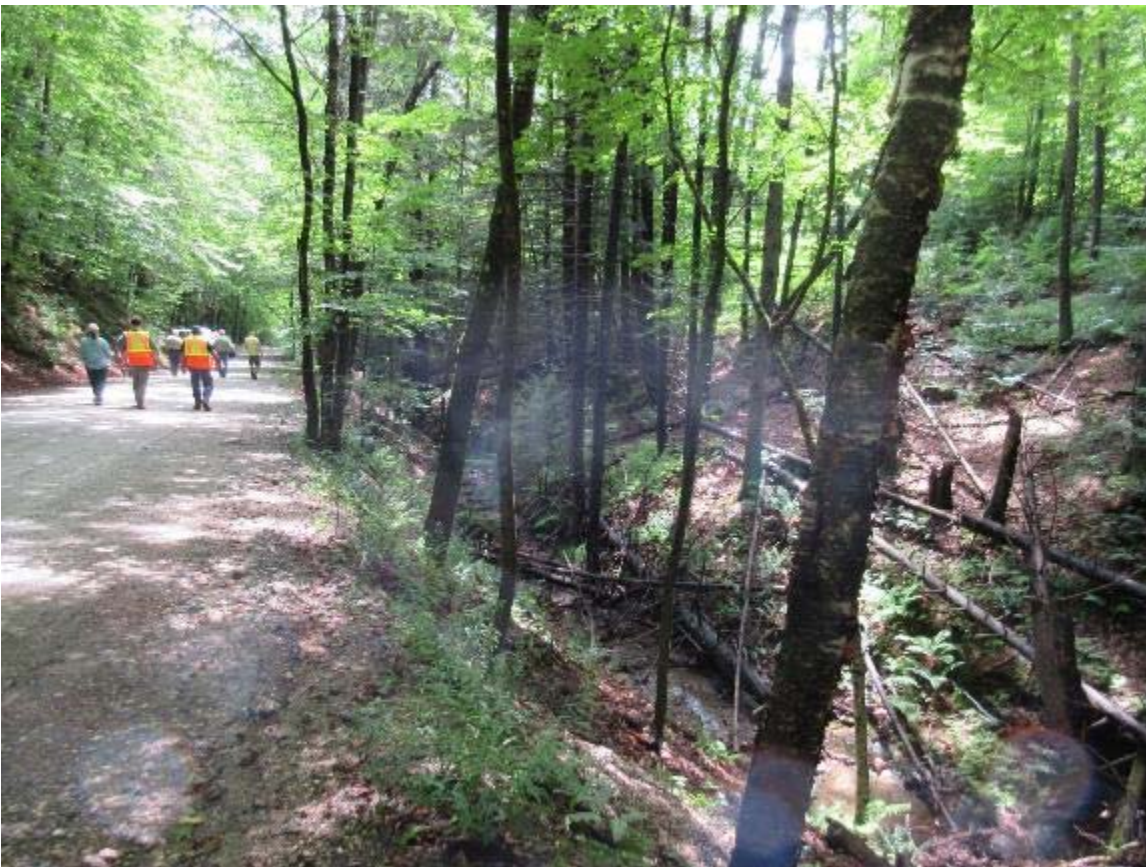
Top: Looking uphill with stream running at the bottom of the gully on the left in this photo. This section is an area where allowing the last 3-4ft of roadway to re-vegetate could help add space for road materials to filter

Bottom: Looking downhill with stream on right side of photograph.
