Town of Reading Road Erosion Inventory 2016

Completed by Southern Windsor County Regional Planning Commission and the Town of Reading

Fieldwork completed June/ July 2016
Report last revised December 12, 2016

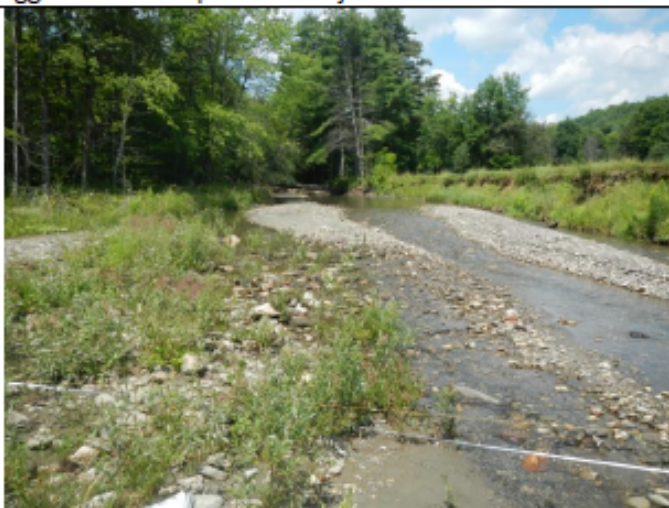
Widening and major deposition at the cross-section

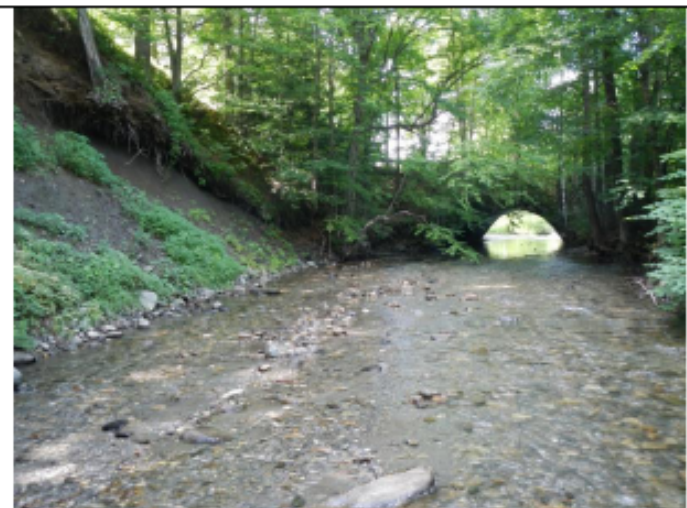
- Project RE 3: Arch Replacement - Agony Hill Road arch is undersized and causing major sediment accumulation upstream and exacerbated flooding and road damage during T.S. Irene.
- Project RE 4: Conservation - Valuable forested floodplain on the right bank
- Project RE 1 c+d: Corridor Protection and Buffer Planting - Two large areas along the left bank have minimal woody vegetation and should be protected from future development.

Undersized arch and downstream mass failure

We recommend replacing the arch with a larger structure to better accommodate the large volumes of sediment working through the reach. A structure larger than the predicted bankfull channel width (36 feet) should be considered based on channel adjustment processes (Schiff *et al.*, 2014). The floodplain spillway over the road should be stabilized but not elevated. Additional projects to protect floodplain (RE 4) and stabilize and plant an eroding bank (RE 1d) should be considered for implementation before or during any structure replacement. VTrans and the Town of Reading are potential partners for this project.

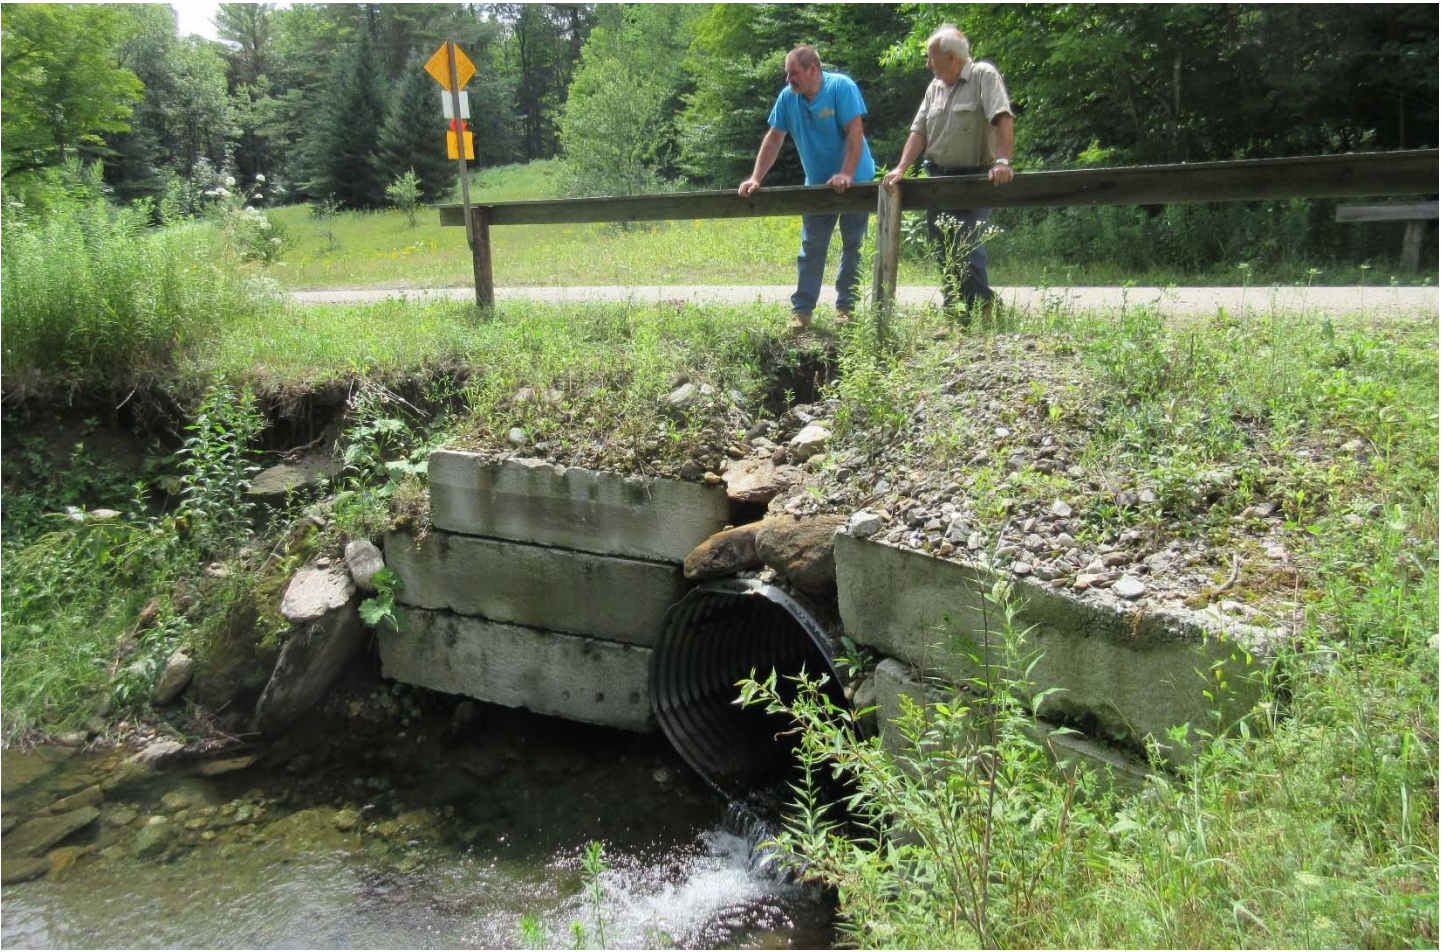
A large culvert on Brown Schoolhouse Road which conveys a perennial stream is failing – bottom is starting to rust and get holes, there is serious undercutting around the downstream end of the culvert, and part of the cover above the culvert is destabilizing at the edge of the roadway. Between visiting the site in late June and early August the edge of the roadway destabilized considerably.

Top: Downstream end of culvert. Culvert and headers are undercutting. Cover above the culvert is destabilizing at the edge of the roadway. August 2, 2016

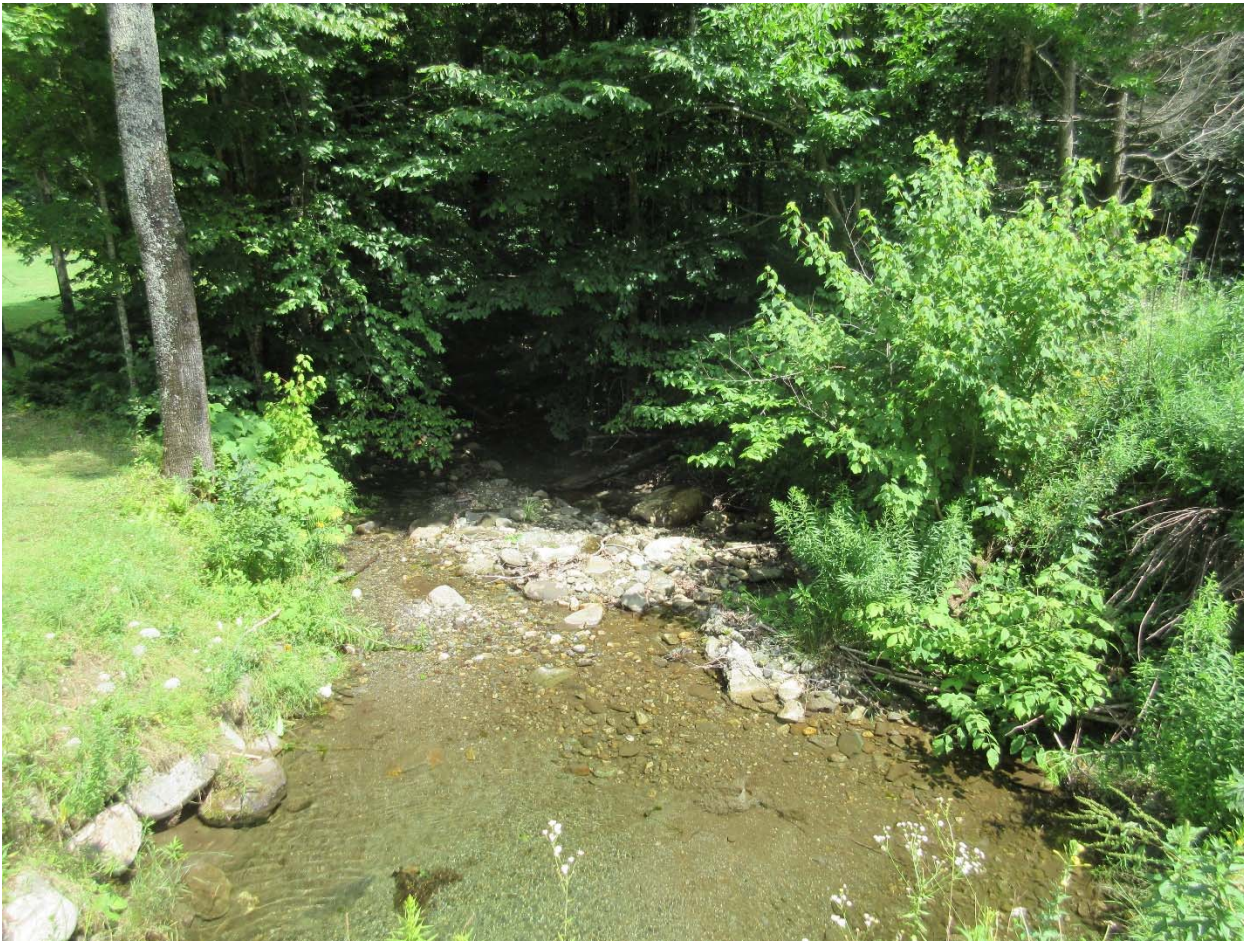
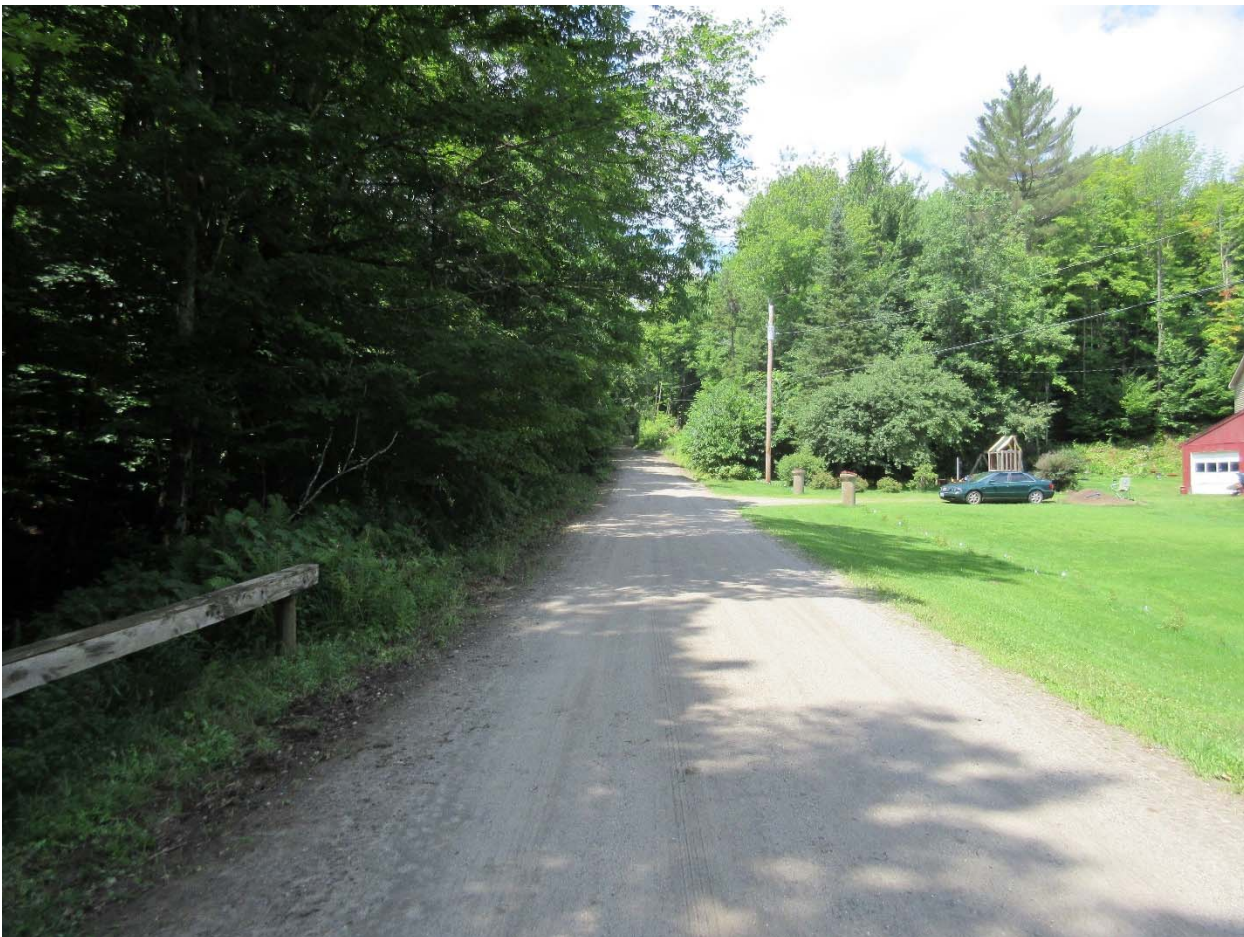
Top: Looking downstream from the culvert. Plunge pool is in the foreground and then the stream narrows up.

Bottom: Looking up the road (westward). Stream runs through the trees on the left.

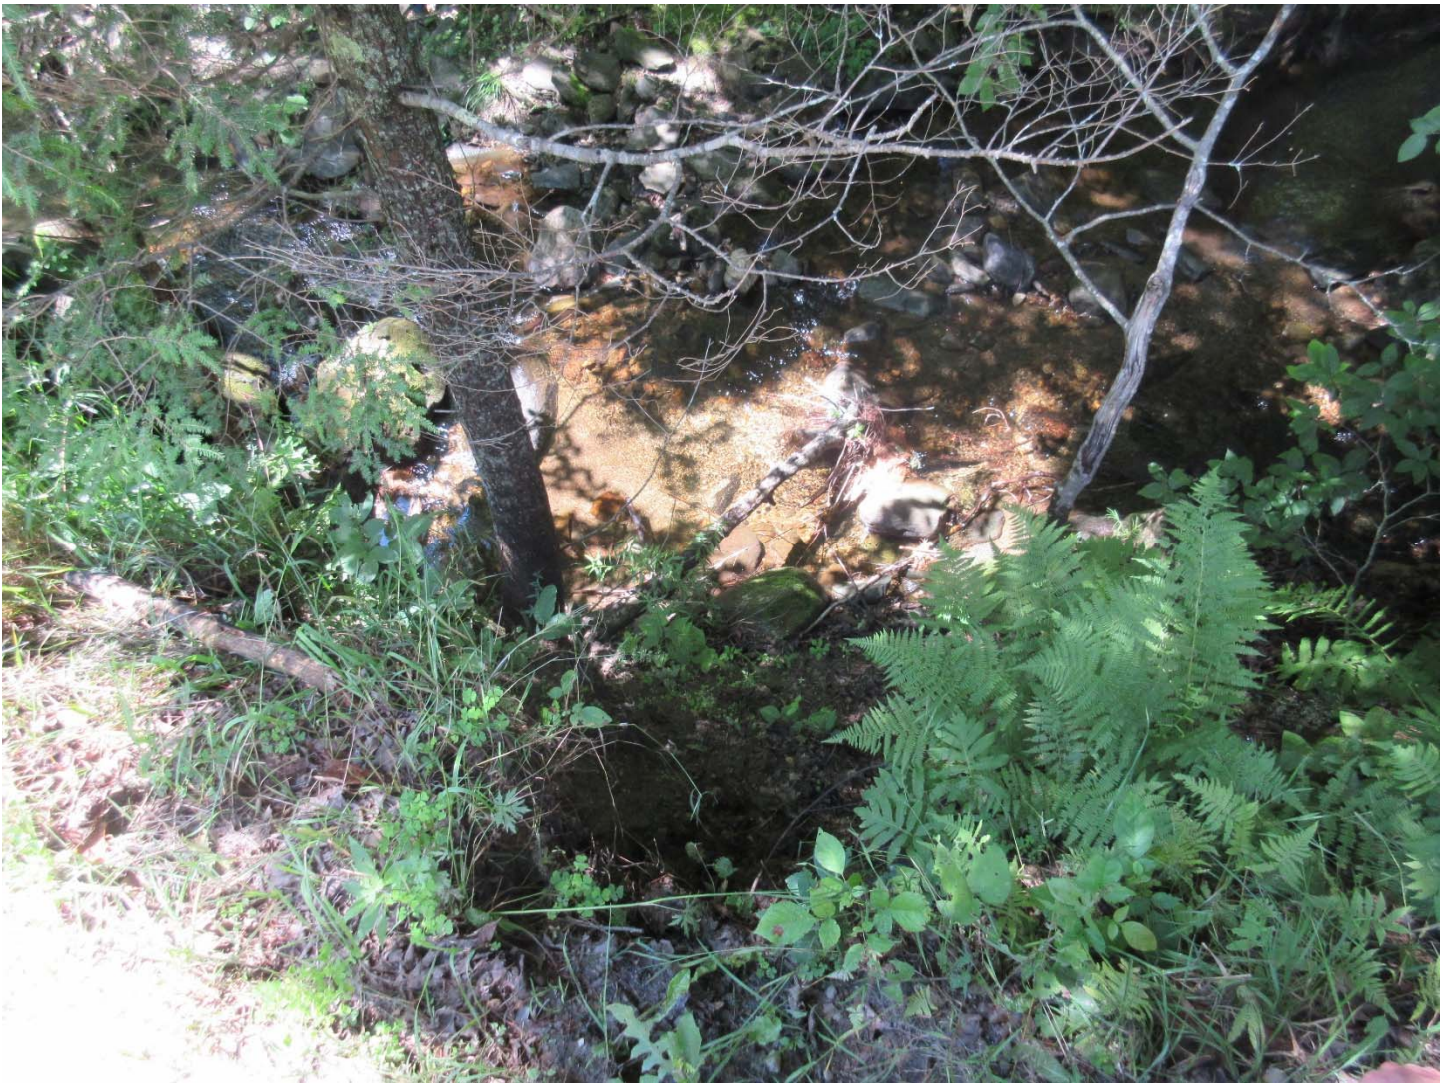
Stream runs very close to the roadway. The stream bank is already beginning to fail along the roadway at a corner of the stream where there are insufficient trees and/or stone on the bank. The issue is being caused by the movement of the stream (the corner is slowly moving upstream) rather than the roadway. The stream will likely undercut the roadway if the bank is not stabilized or the road moved away from the edge of the stream.

All: Bank destabilizing where trees stop.

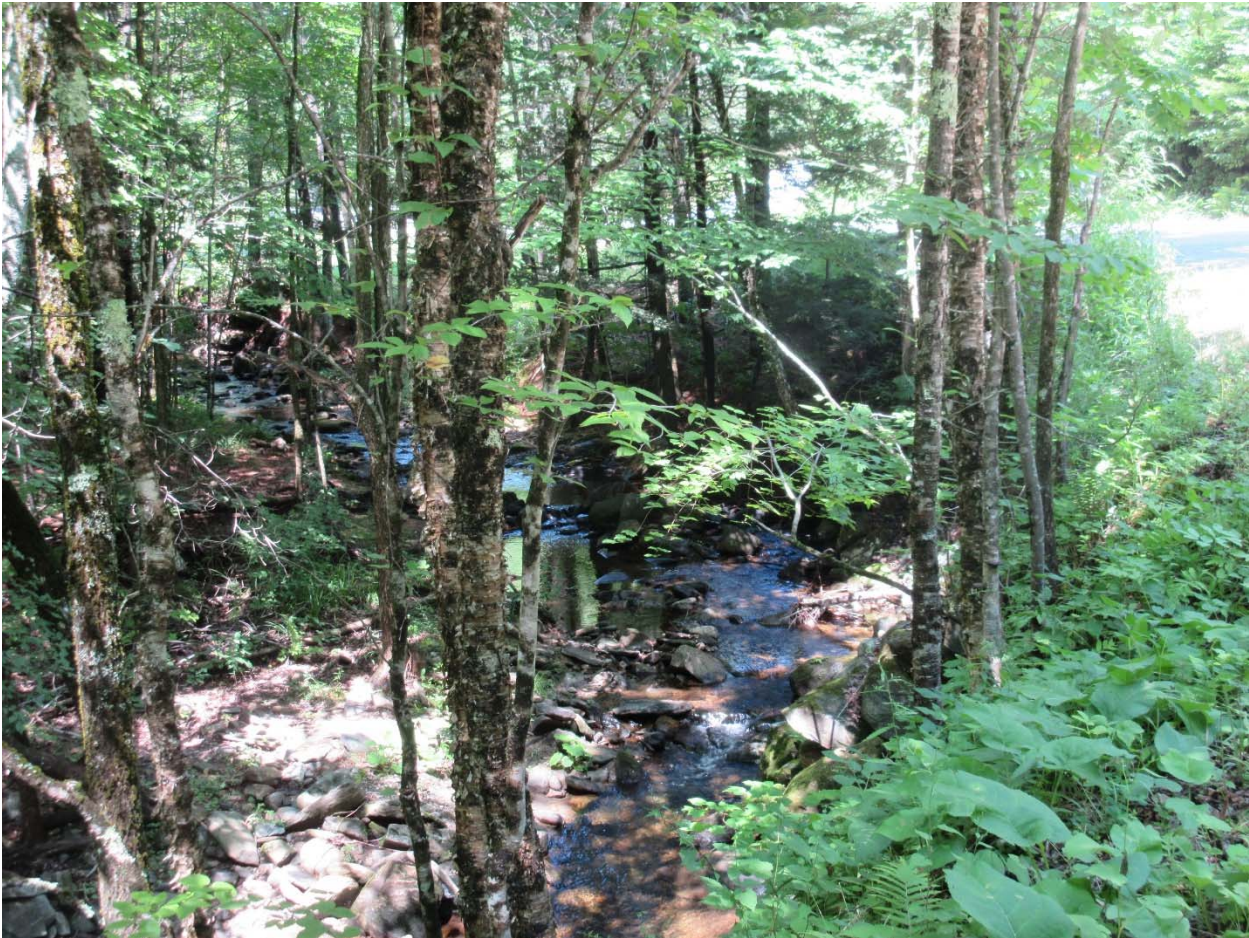
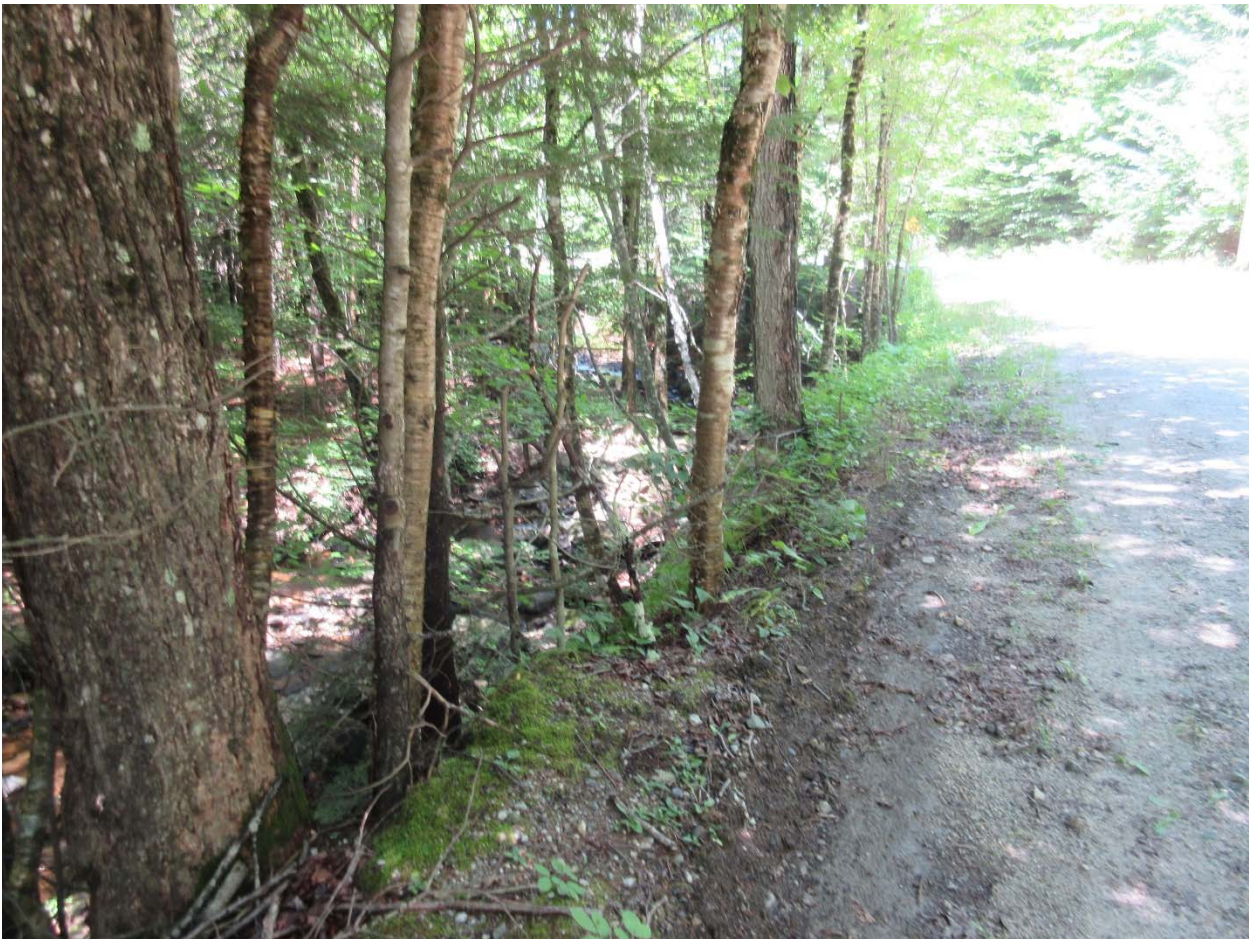
Top and Bottom:
Stream
curve next
to roadway.
Areas with
bigger trees
are holding
well. Areas
with smaller
trees or no
trees are
unstable.
