**Vacant Parcel
133 – 139 Main Street
Windsor, Vermont 05089**

KAS#507210630

PHASE II ENVIRONMENTAL SITE ASSESSMENT REPORT

October 22, 2021

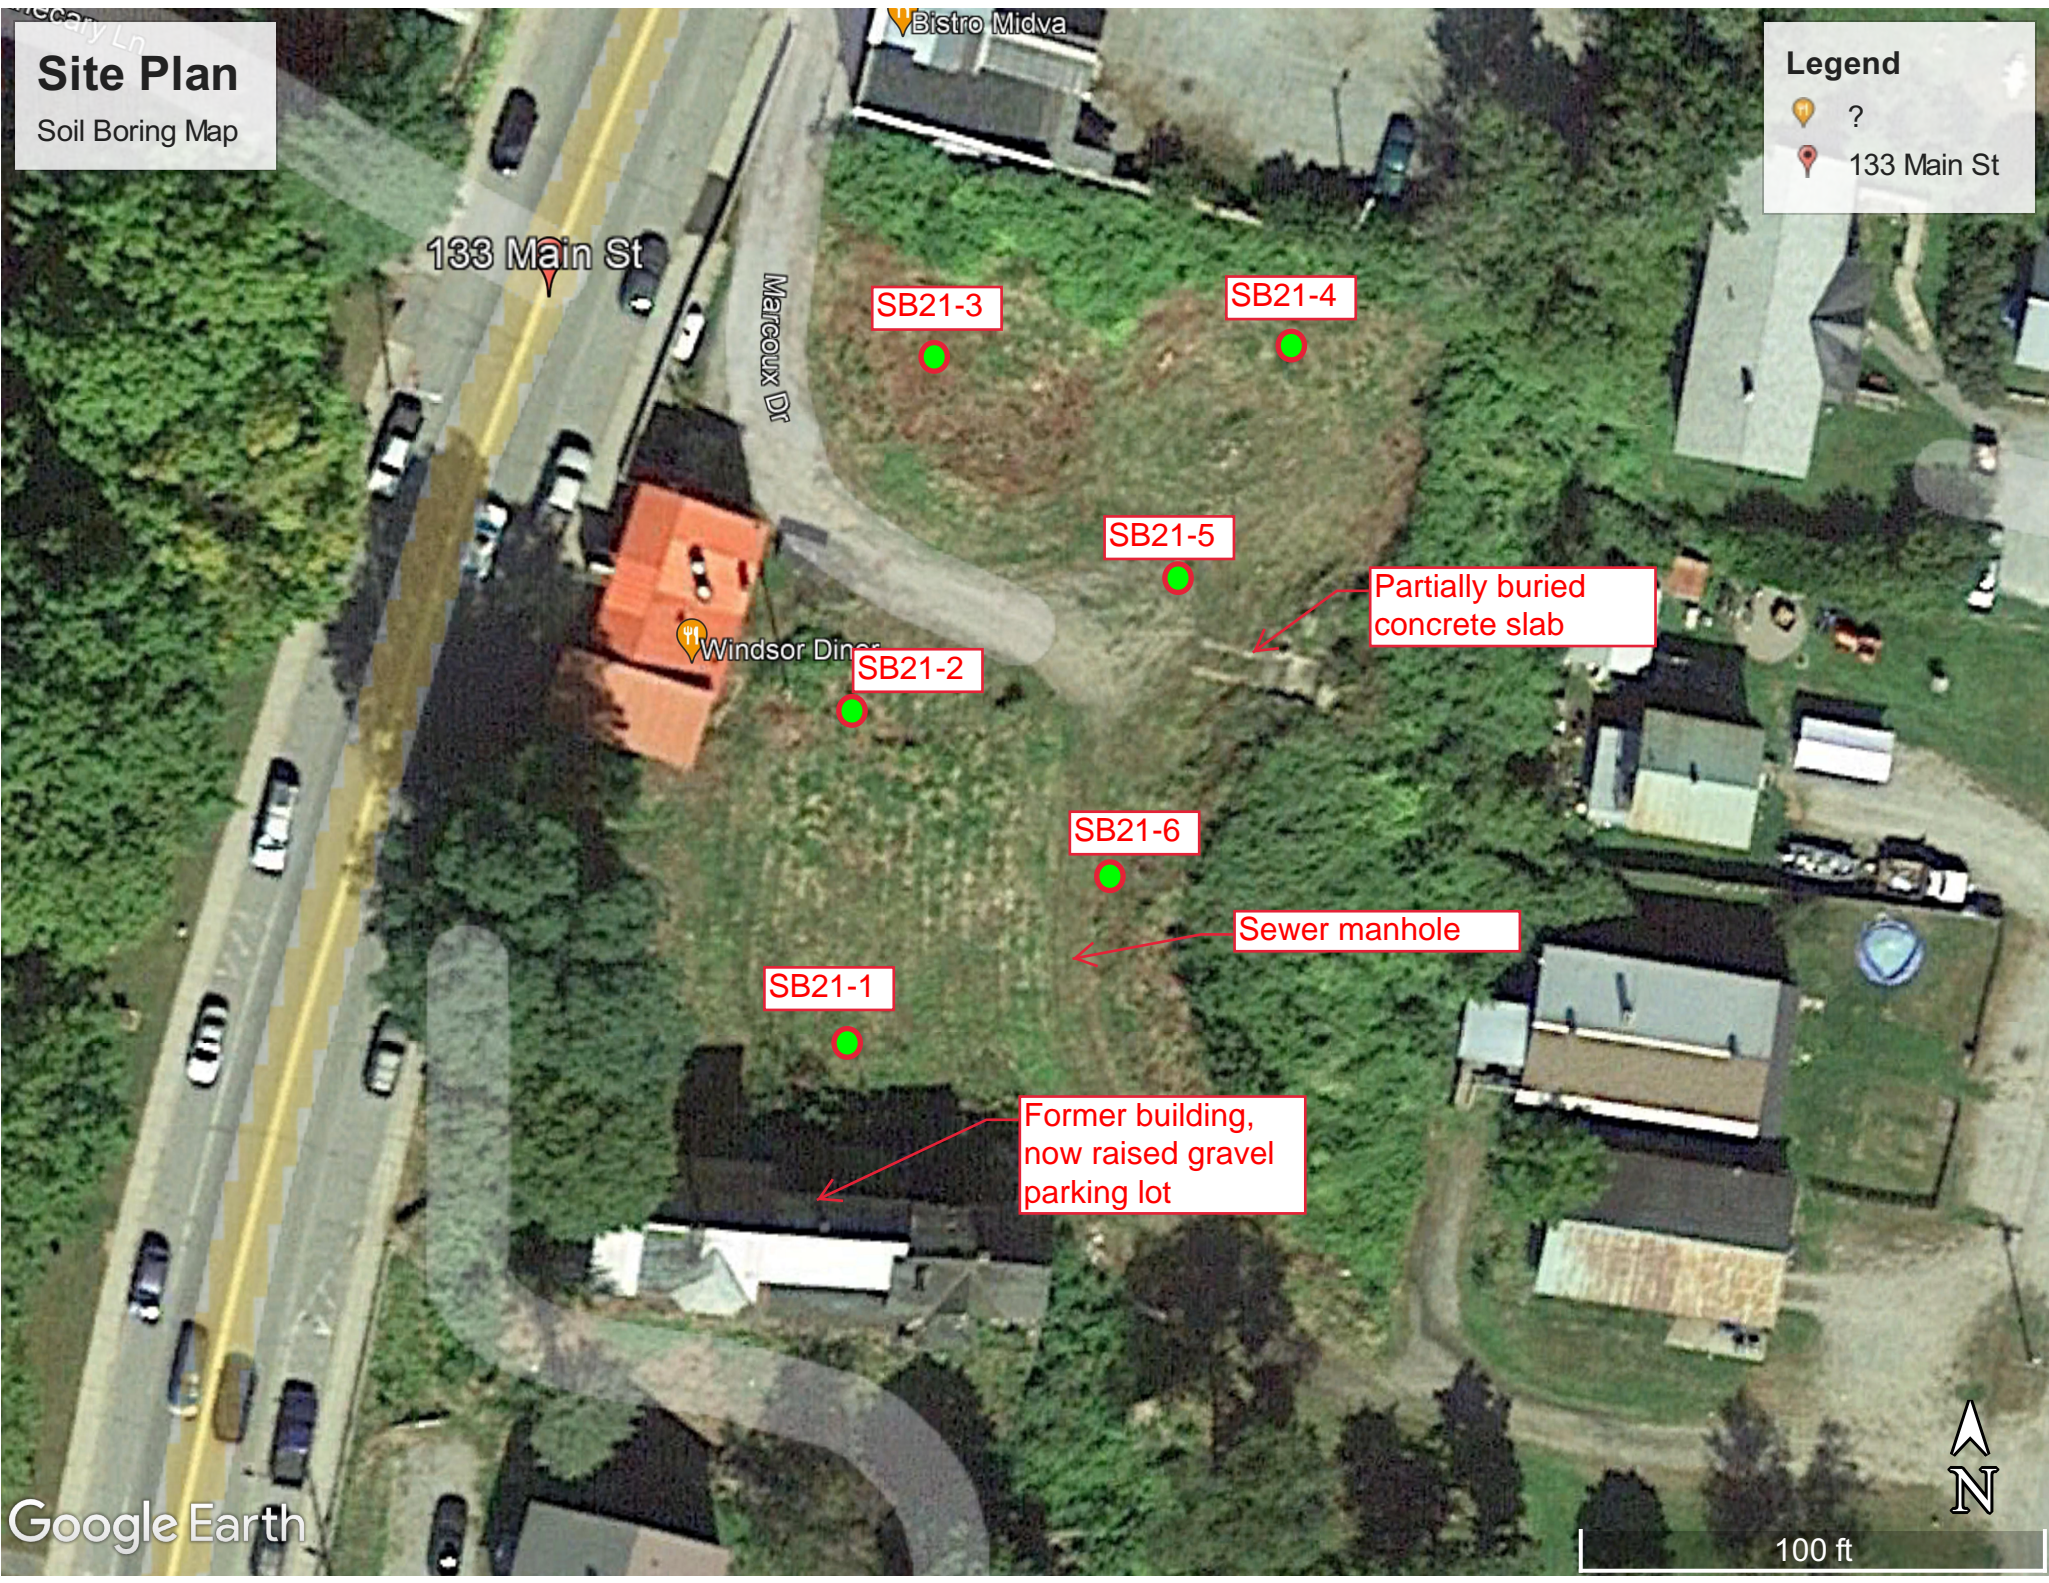
Soil Boring Map

On October 6, 2021 six (6) soil borings (SB21-1 through SB21-6) were advanced by KAS using a track-mounted Geoprobe 54LT rig under the supervision of a KAS scientist. These soil borings were strategically placed across the property to evaluate the potential presence of urban fill. Soil boring locations are presented in Appendix A. Photographic documentation is presented in Appendix B.

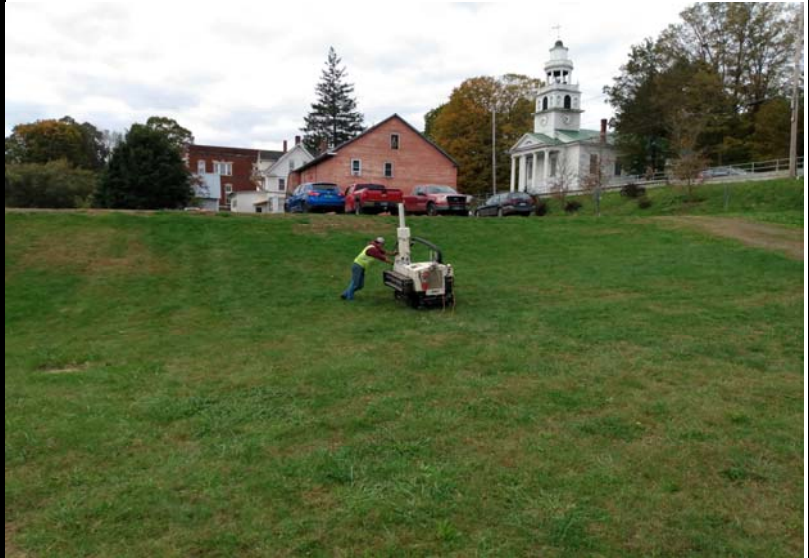
Photograph ID: 001
Date: October 6, 2021
Location:
Property
Direction:
Facing south
Comments:

View during the advancement of soil boring SB21-1 along the southern portion of the property.

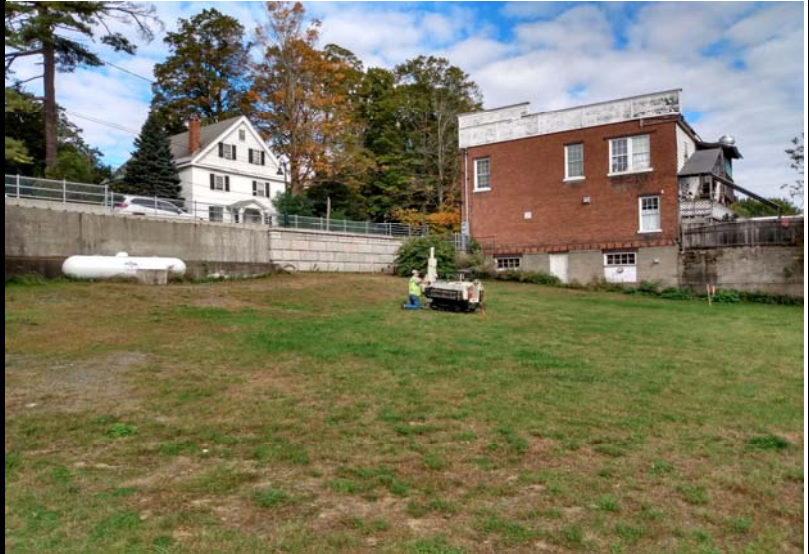
Photograph ID: 002
Date: October 6, 2021
Location:
Property
Direction:
Facing northwest
Comments:

View during the advancement of soil boring SB21-3 along the northern portion of the property.
