# Hubbard Brook Phase 1 Stream Geomorphic Assessment Summary

December 11, 2008

**Fitzgerald Environmental Associates, LLC.**

Southern Windsor County  
Regional Planning Commission  
PO Box 320  
Ascutney, VT 05030

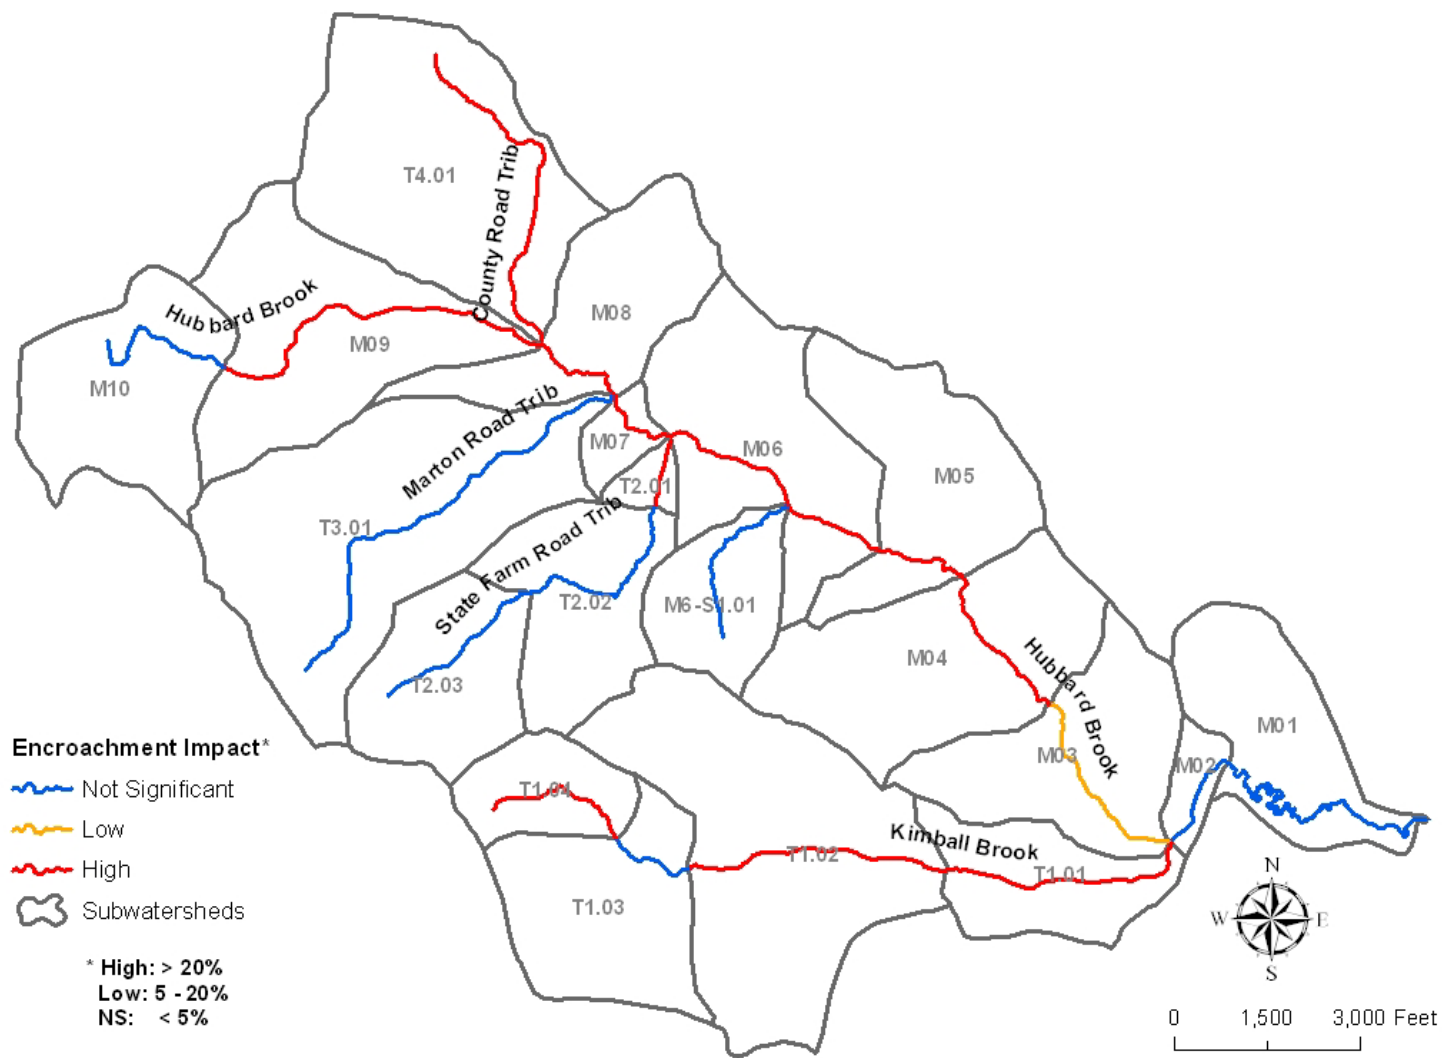
Following the Phase 1 protocol, any berms, roads, driveways, railroads and/or improved paths found within the stream corridor were indexed using the FIT. These areas were identified using the 2003 NAIP aerial imagery, and were confirmed and/or refined during the field observations. Figure 11 depicts the reaches where encroachment has significantly impacted the stream corridor, with ratings based on the percentage of the reach length that was impacted as indicated in Table 8. All encroachments noted in the watershed were from roads (Figure 12), however further Phase 2 assessments may reveal additional berm encroachments that were not observed remotely or during the windshield surveys.

**Figure 11.** Impacts from corridor encroachments in the Hubbard Brook watershed

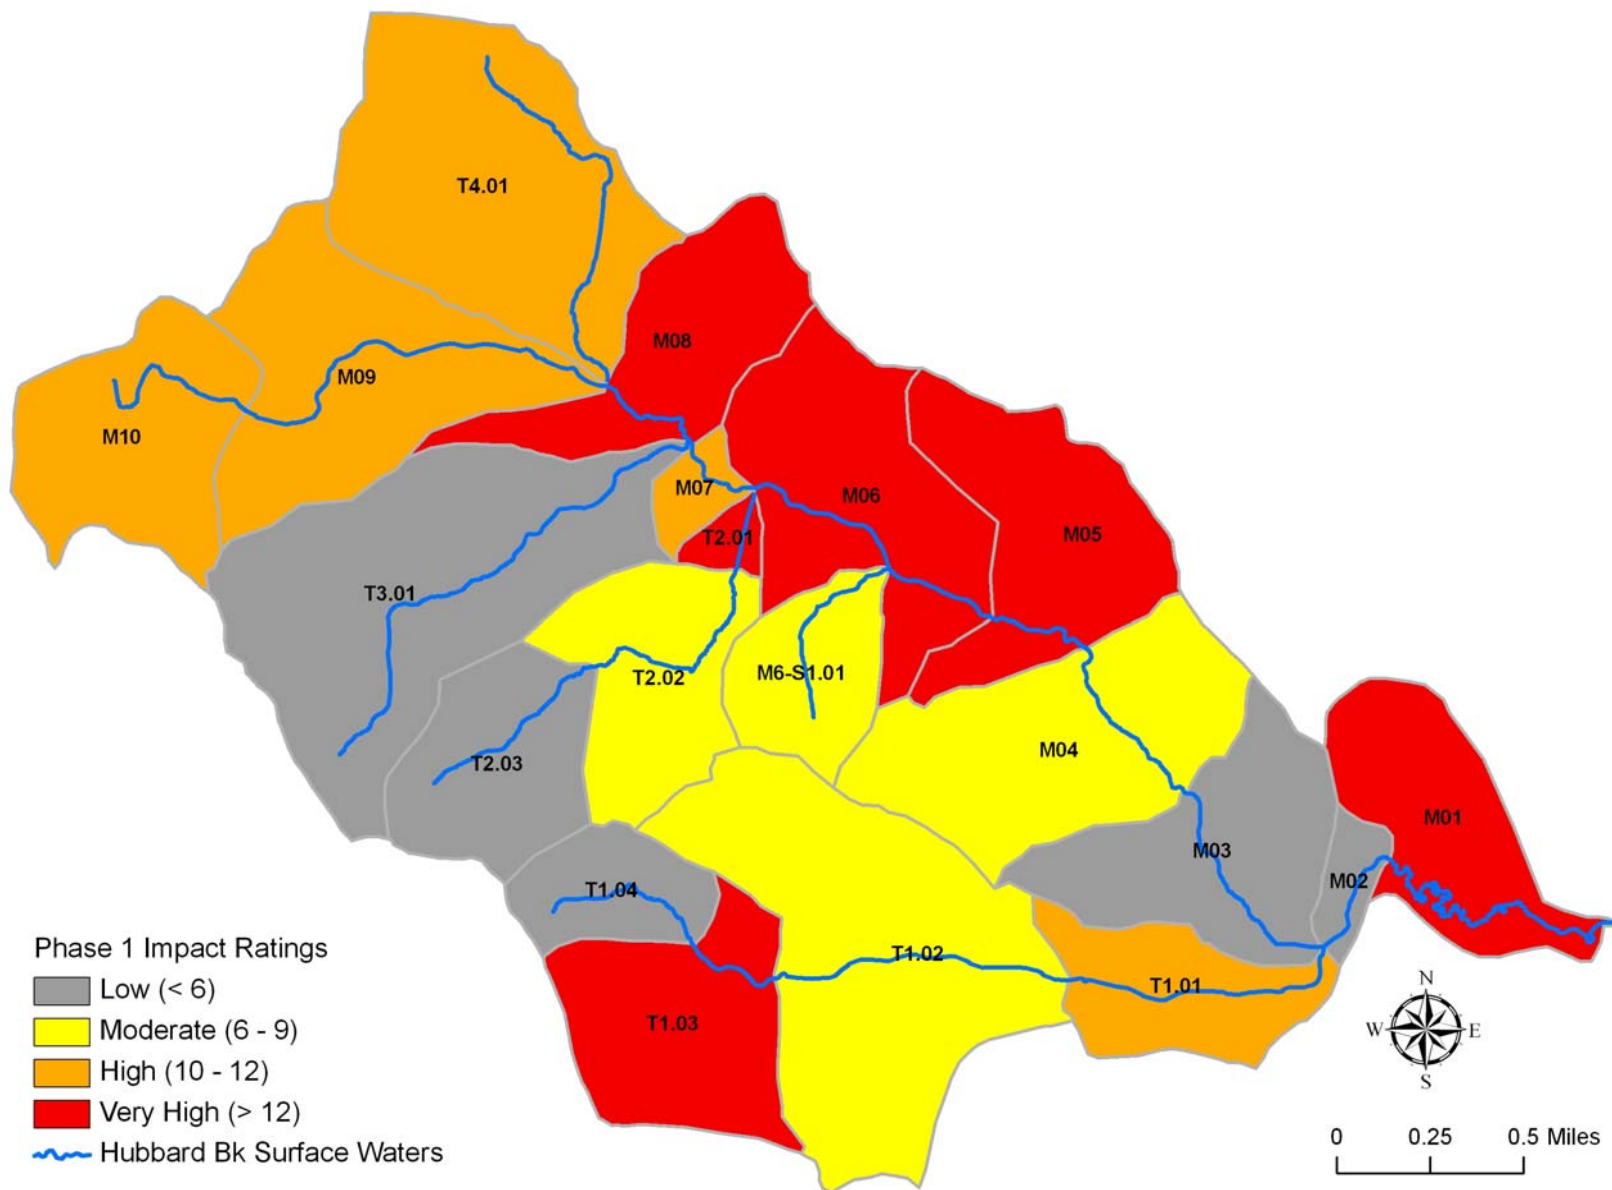
Figure 15. Phase 1 final impact ratings for the Hubbard Brook subwatersheds and reaches

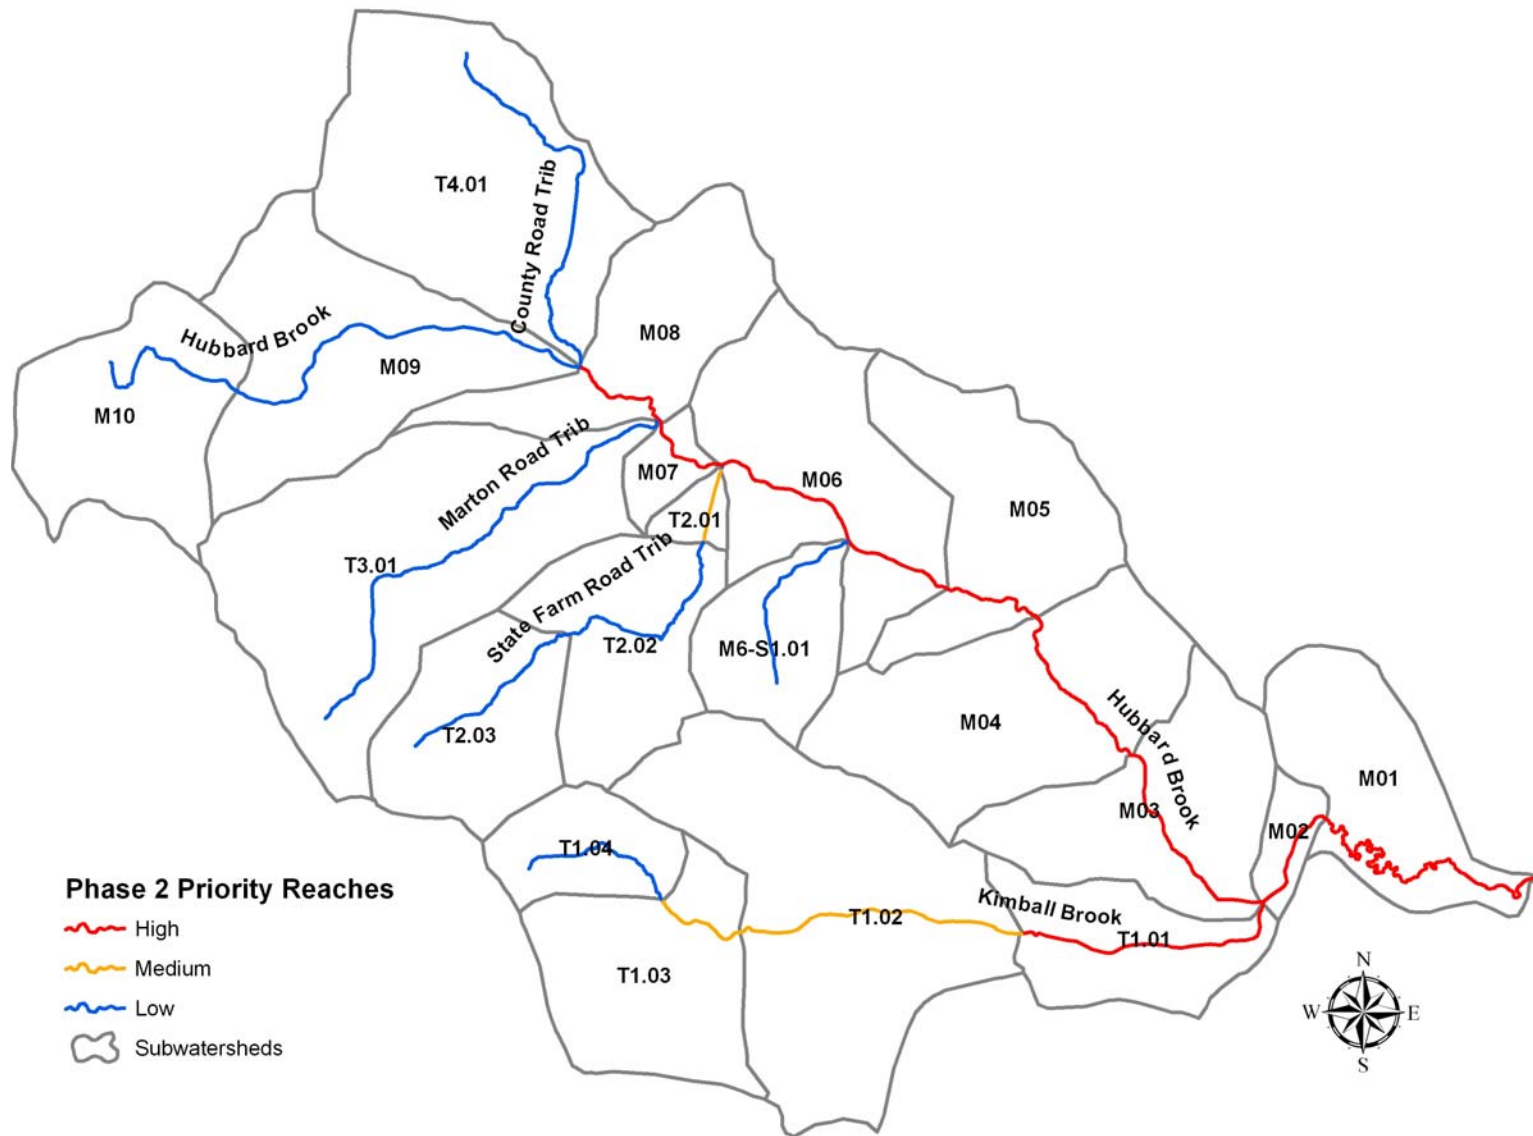
Using the Phase 1 Impact Ratings as the primary basis for reach selection, a list of high and medium-priority reaches has been compiled for further Phase 2 surveys. Figure 16 presents the selected reaches by location in the watershed. Table 12 summarizes the selected reaches based on watershed location, channel length, and preliminary reference stream type.

Three (3) additional reaches have been included as medium-priority reaches due to their relative impact ranking and location in the watershed. Kimball Brook reaches T1.02 and T2.03 were chosen because of the significant size of the upslope drainage area and their high impact scores. T1.03 had extensive impacts from agricultural activities and could be a potential site for a buffer enhancement project (see Figure 10). State Farm Road tributary, reach T2.01, was also chosen as a medium priority reach because of the extensive restoration project that was done to manage erosion of the left bank. Field observations revealed a mass failure that may be related to the recent restoration efforts.

Figure 16. Selected reaches for Phase 2 assessment
