Town of Reading Road Erosion Inventory 2016

Completed by Southern Windsor County Regional Planning Commission and the Town of Reading

Fieldwork completed June/ July 2016
Report last revised December 12, 2016

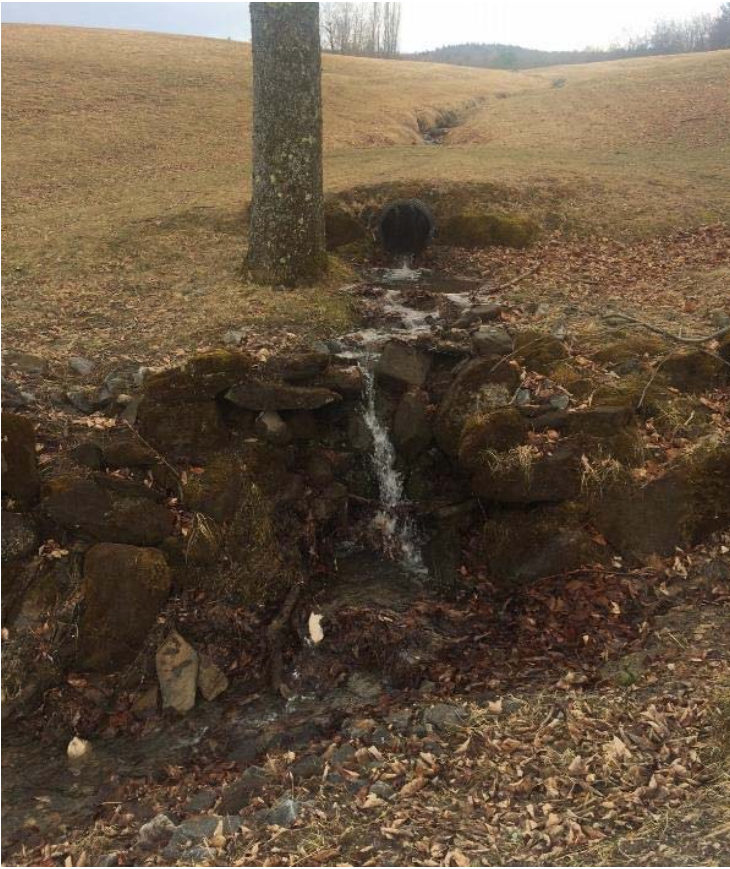
Top: Stream and culvert flowing into site. This water level is typical year round and increases dramatically in the smallest of rain storms.

Bottom: Roadway just above where the project will start

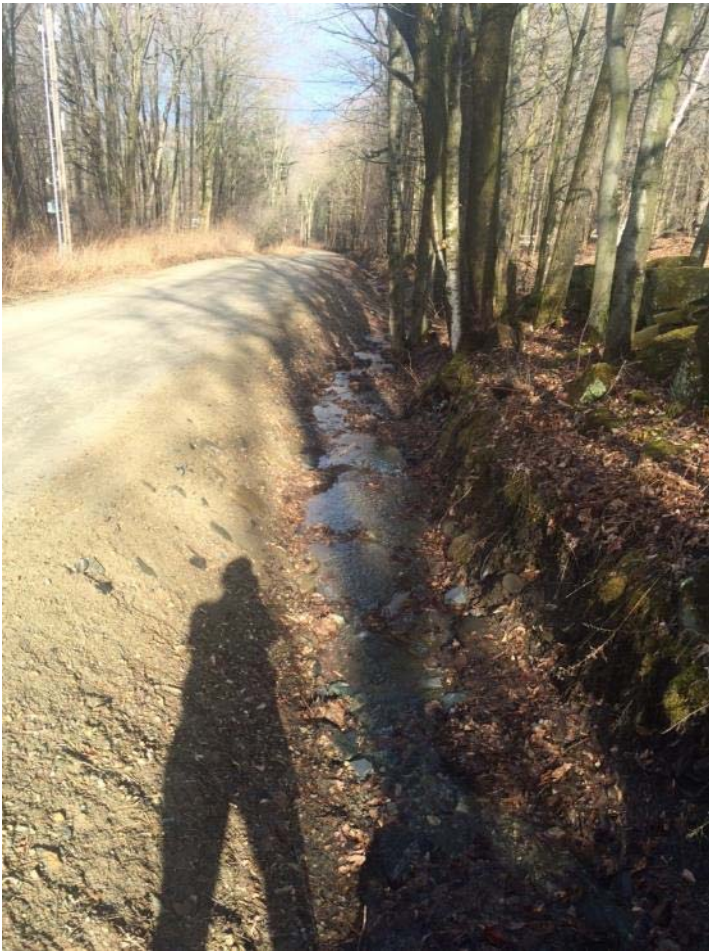
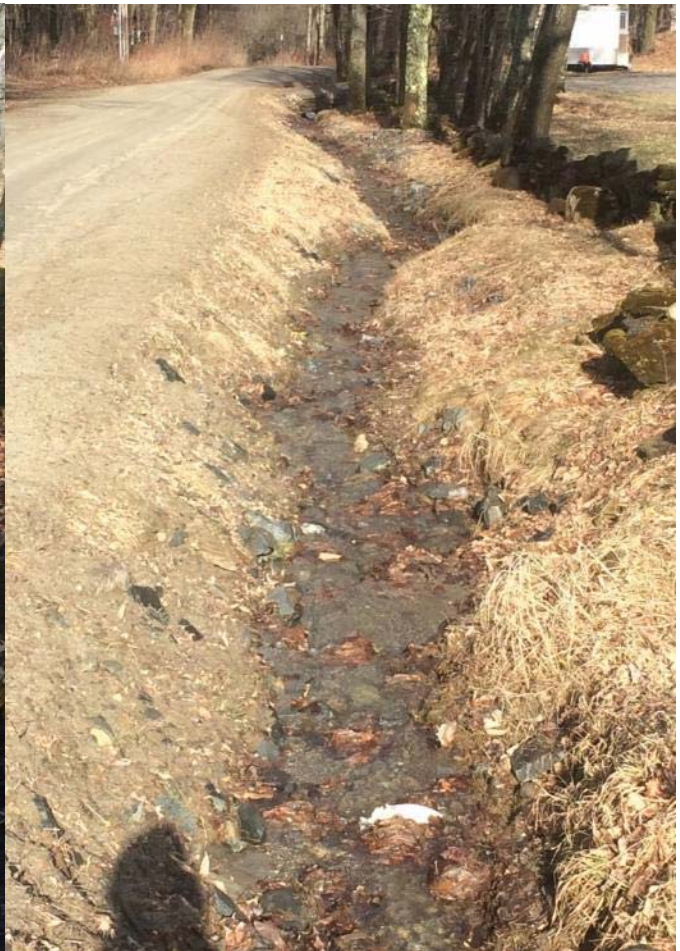
Top left and right: Gullying begins along road

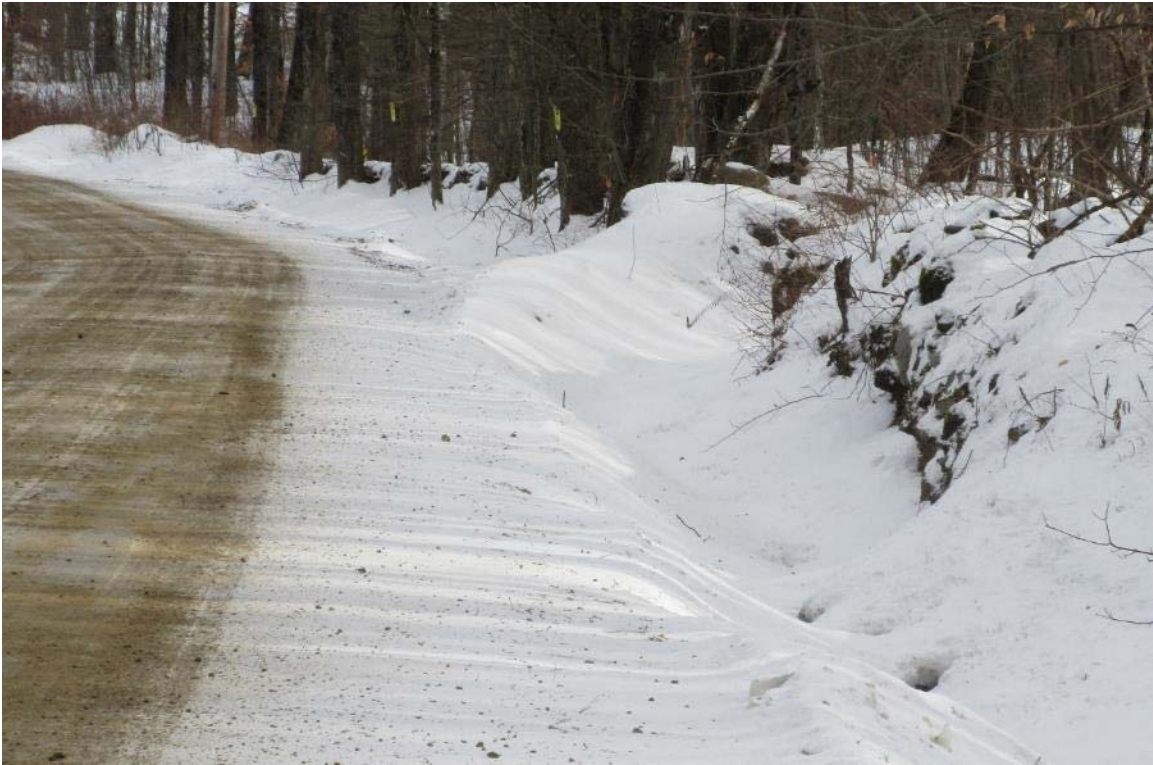
Bottom: Place where ditch turns out to the right into forest. In high water flow water also flows along roadway which turns to the left

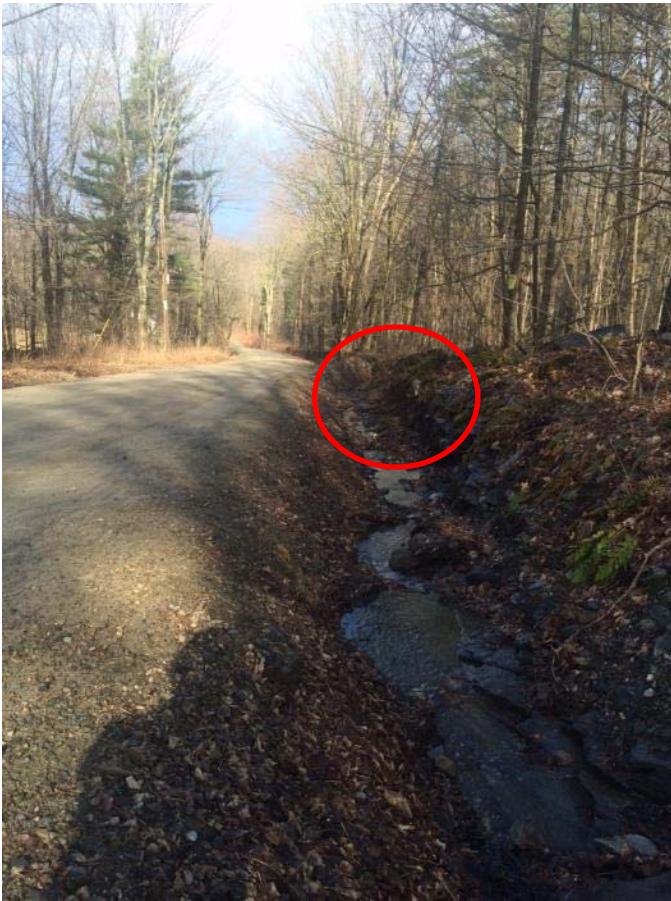
Top Left: Red circle is where the turn out begins

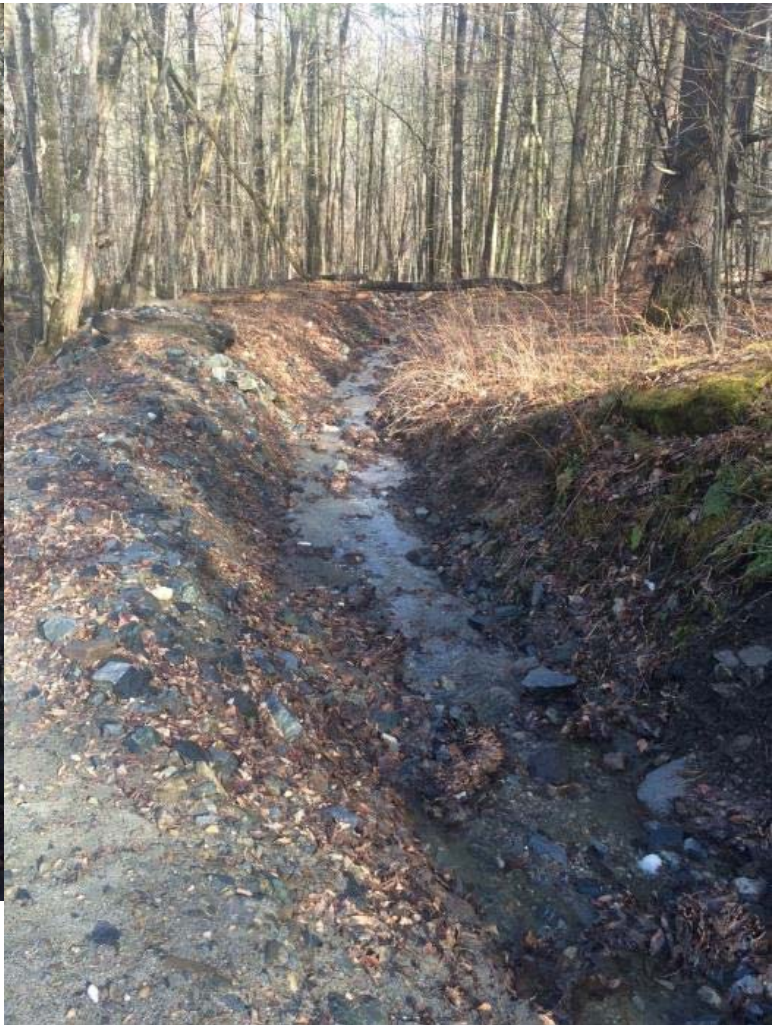
Top Right: Turn out which heads into the woods

Bottom: Water from the road stopping in the woodlands

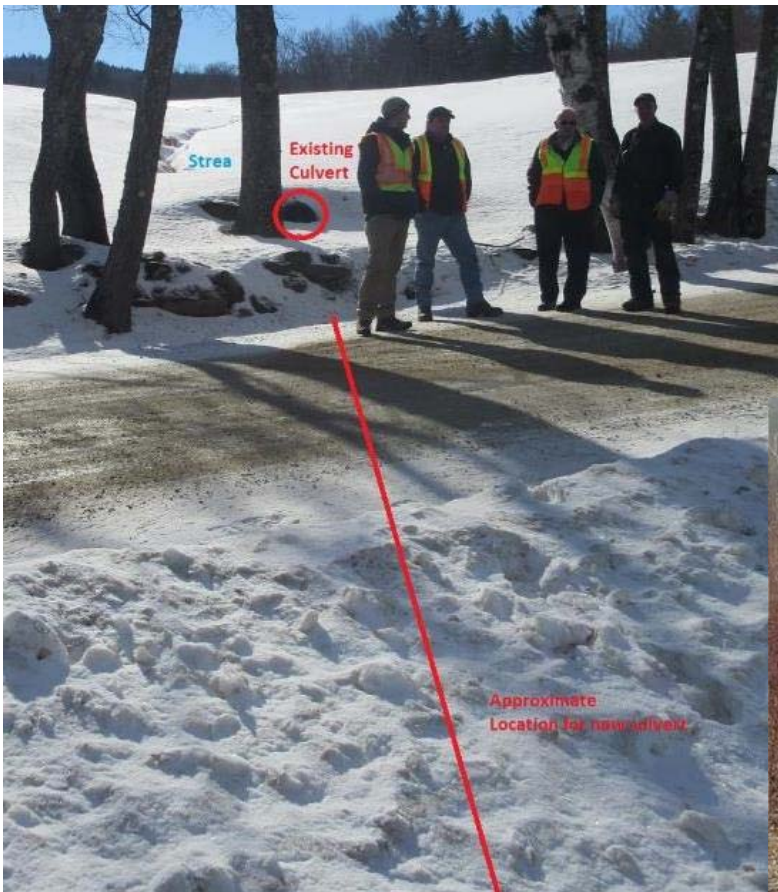
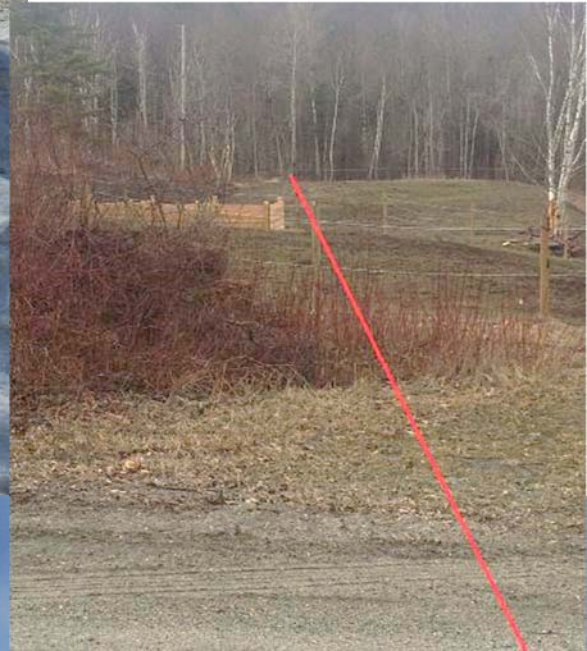
Top: Looking from end of proposed long culvert back to the road (red line shows approximate location of culvert)

Bottom: Existing swale where the culvert will dump into.

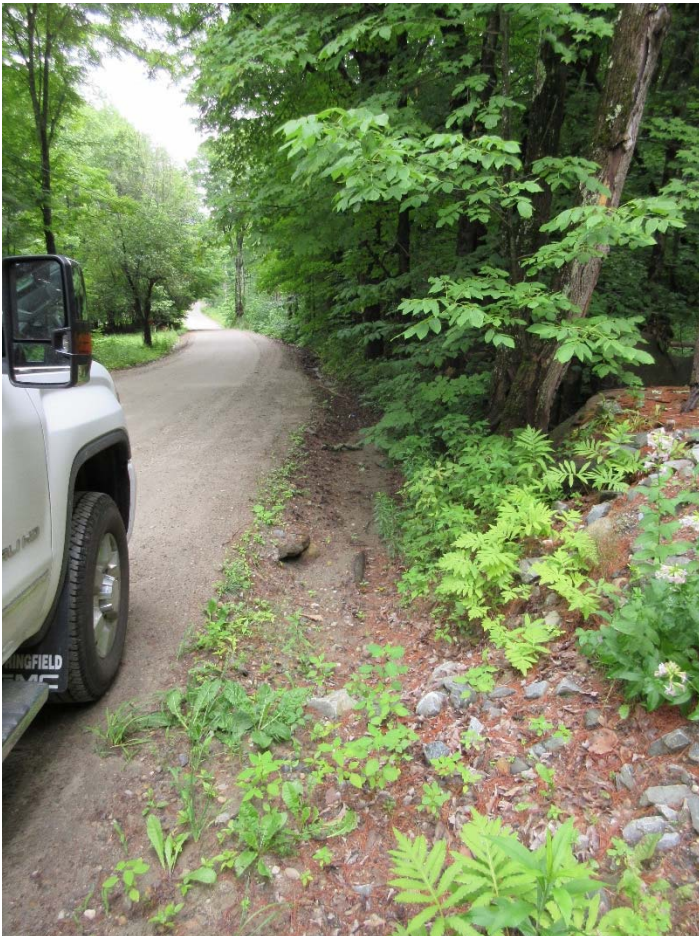
Bottom left: Looking down the ditch which would be stone lined and take the secondary water flow from the sediment pond.

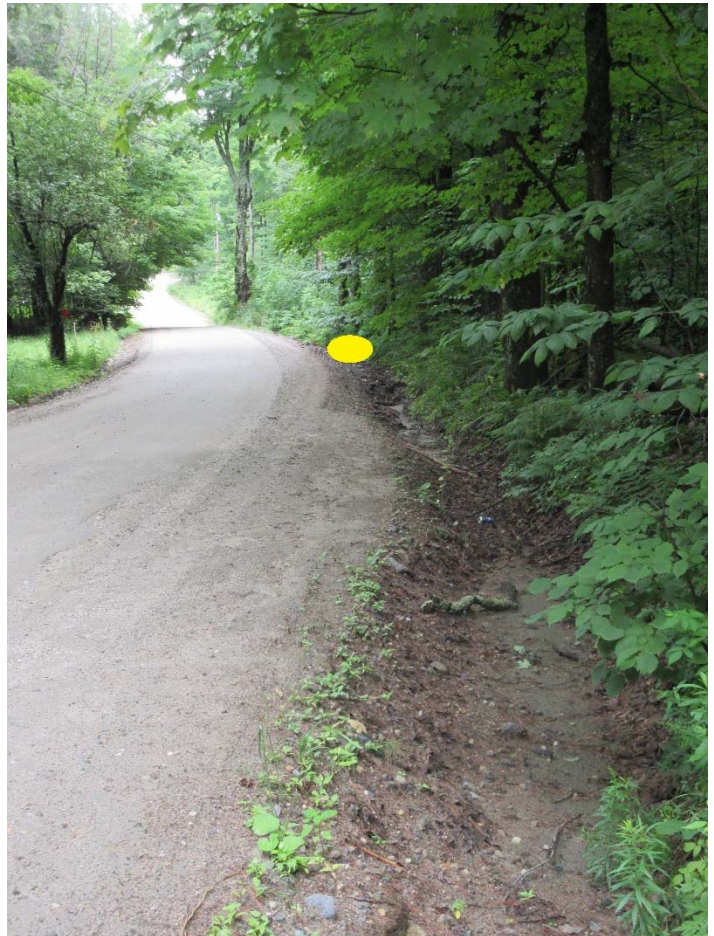
Bottom right: Looking slightly further down the stone lined ditch. The turn out would be approximately where the yellow dot is.

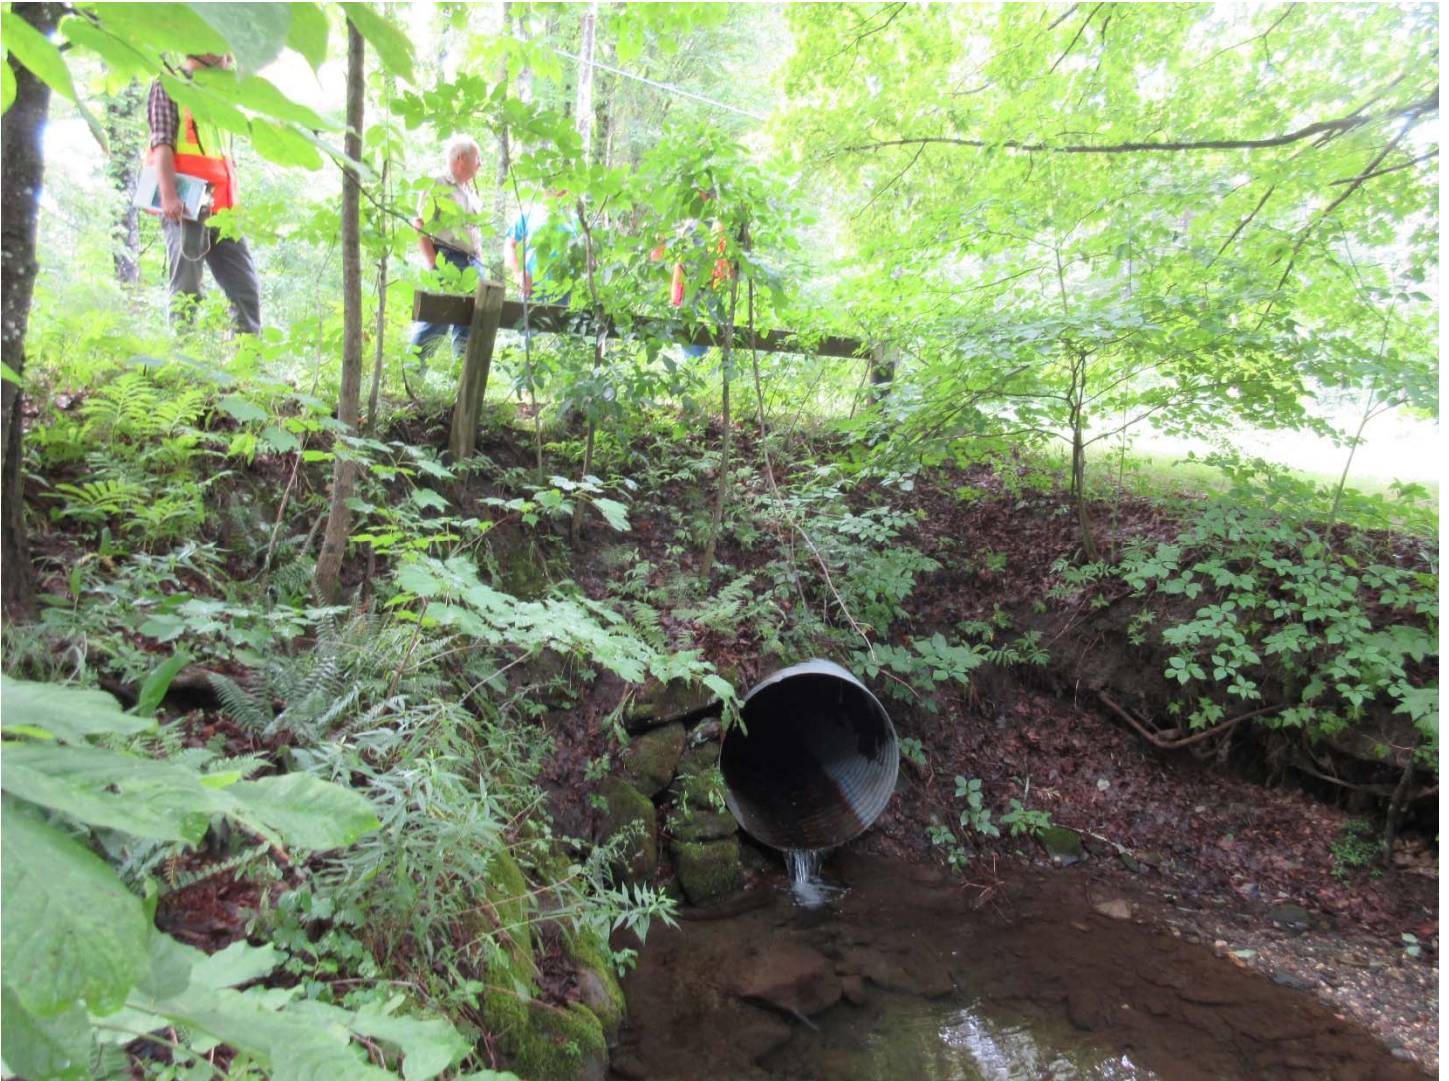
Downstream end of culvert

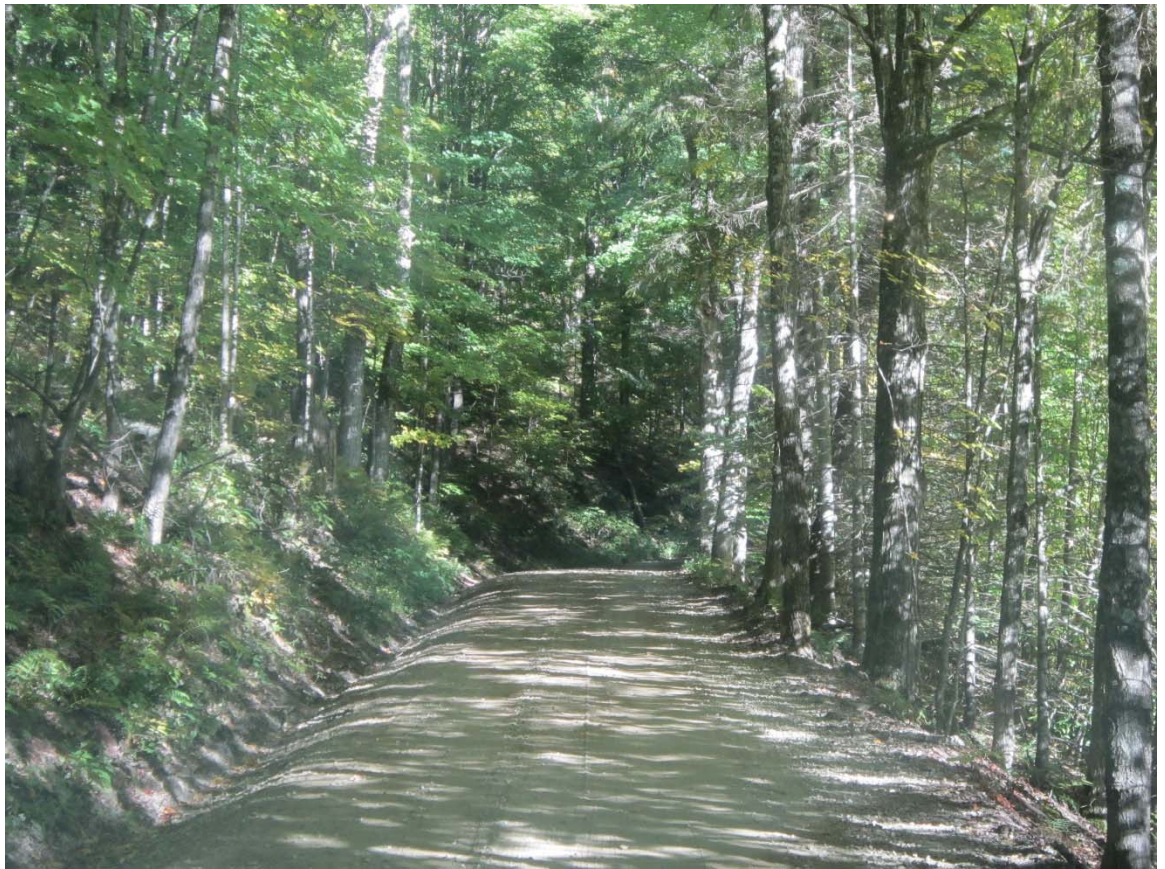
Top: Stone Chimney Road from near Newton Road intersection. Left side of photo is the west side which needs improved ditches. Right side of photo is the steep, yet stable, bank with good tree and vegetation cover.

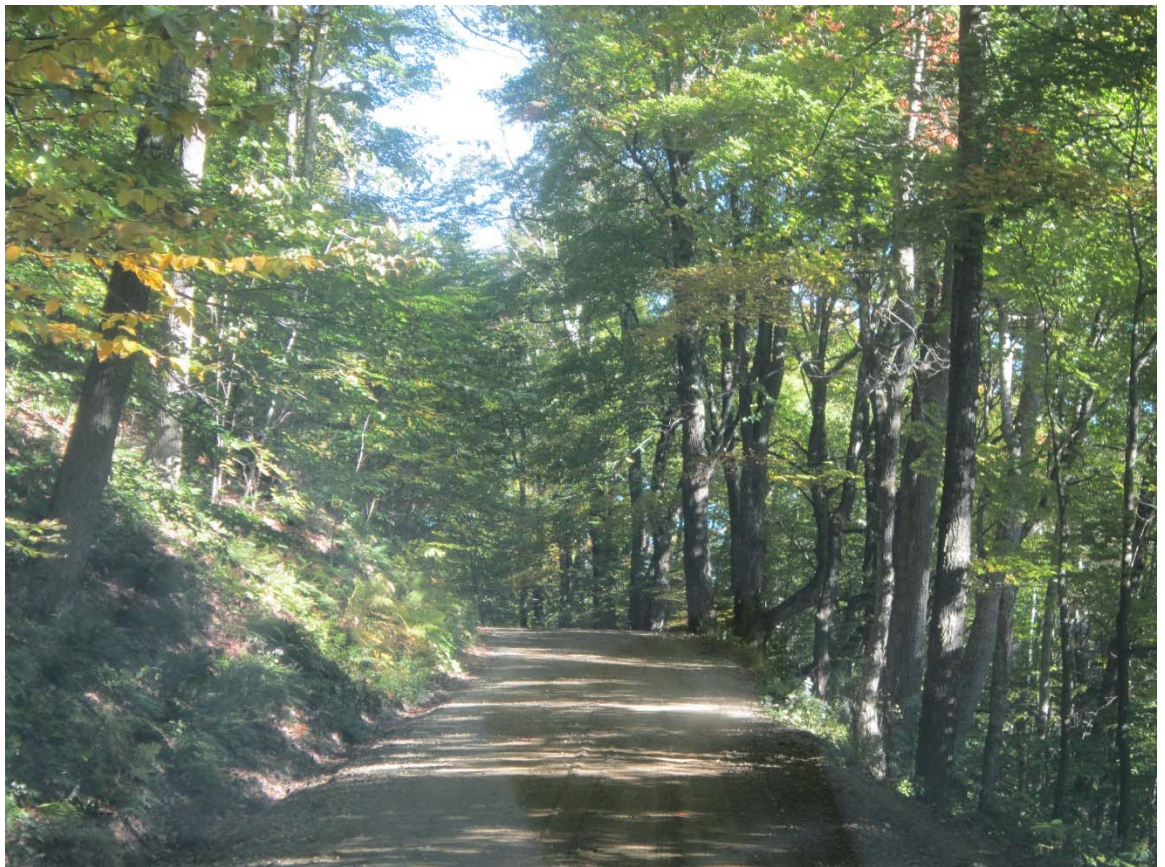
Bottom: Stone Chimney Road near the top of the site, clearly showing the top of the main slope. The ditch that needs improvement is on the left side of the photograph.

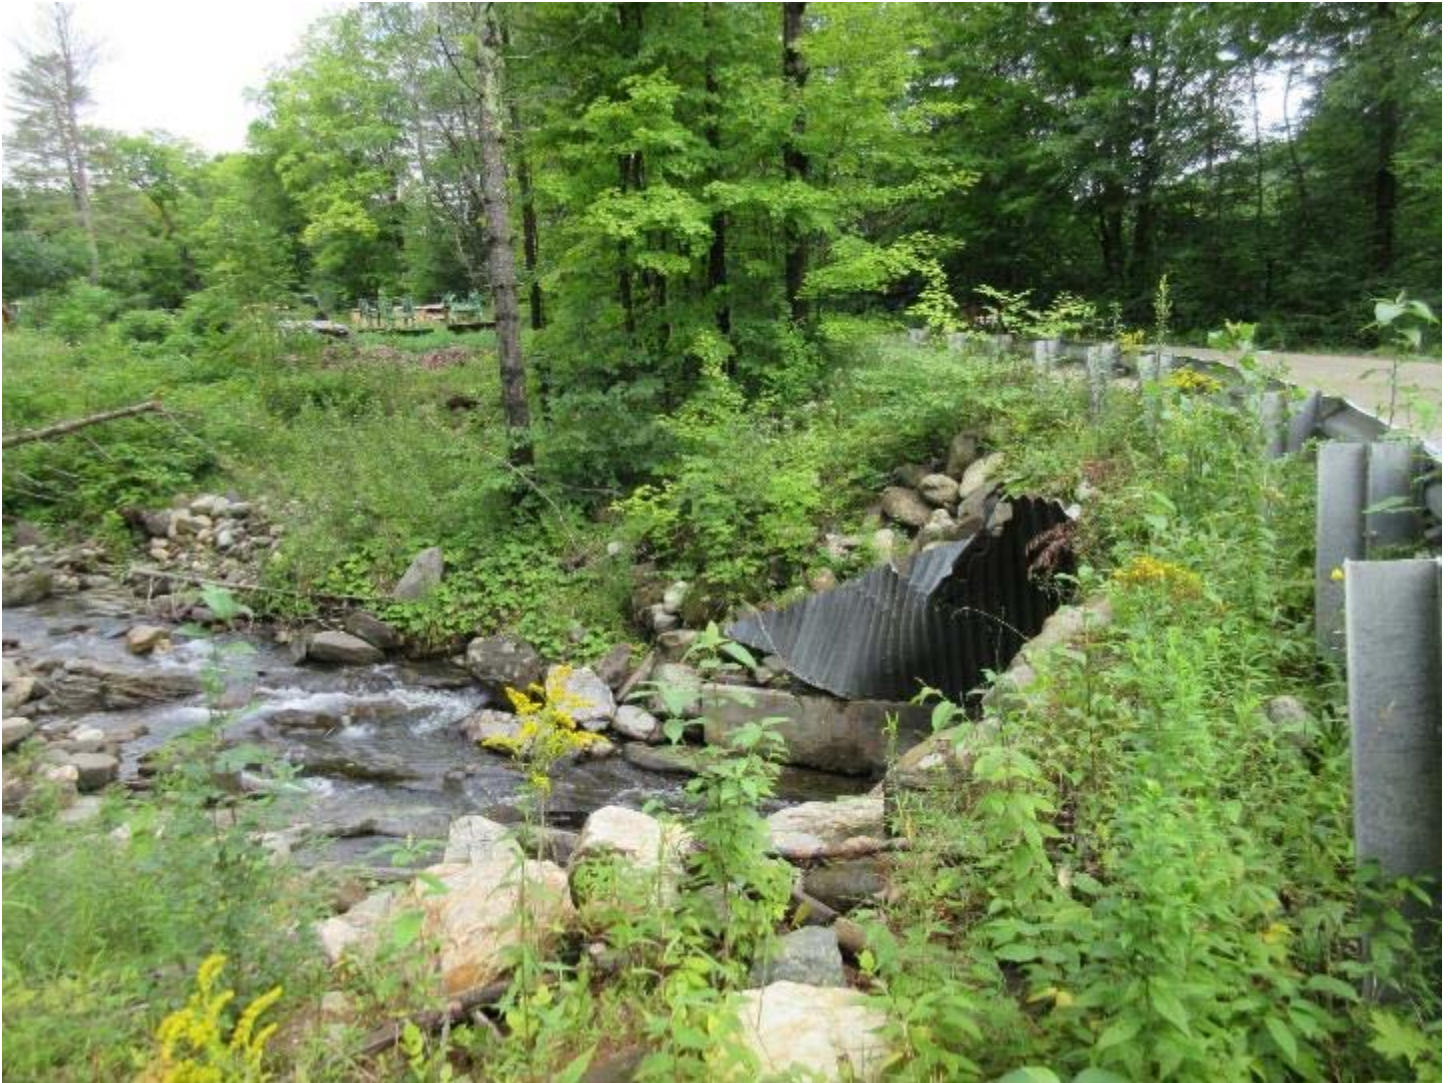
Top: Culvert from intersection of Baileys Mills Road and Town Hill Road

- Increase size of culvert/ install a bridge.
- The Town would like to see the downstream Agony Hill Road Culvert upsized before they resolve this issue – otherwise the increased water flow during high-water events would cause issues there instead.

The 2012 Mill Brook River Corridor Plan estimated the cost of replacement to be \$350,000. Would need scoping and engineering before proceeding.

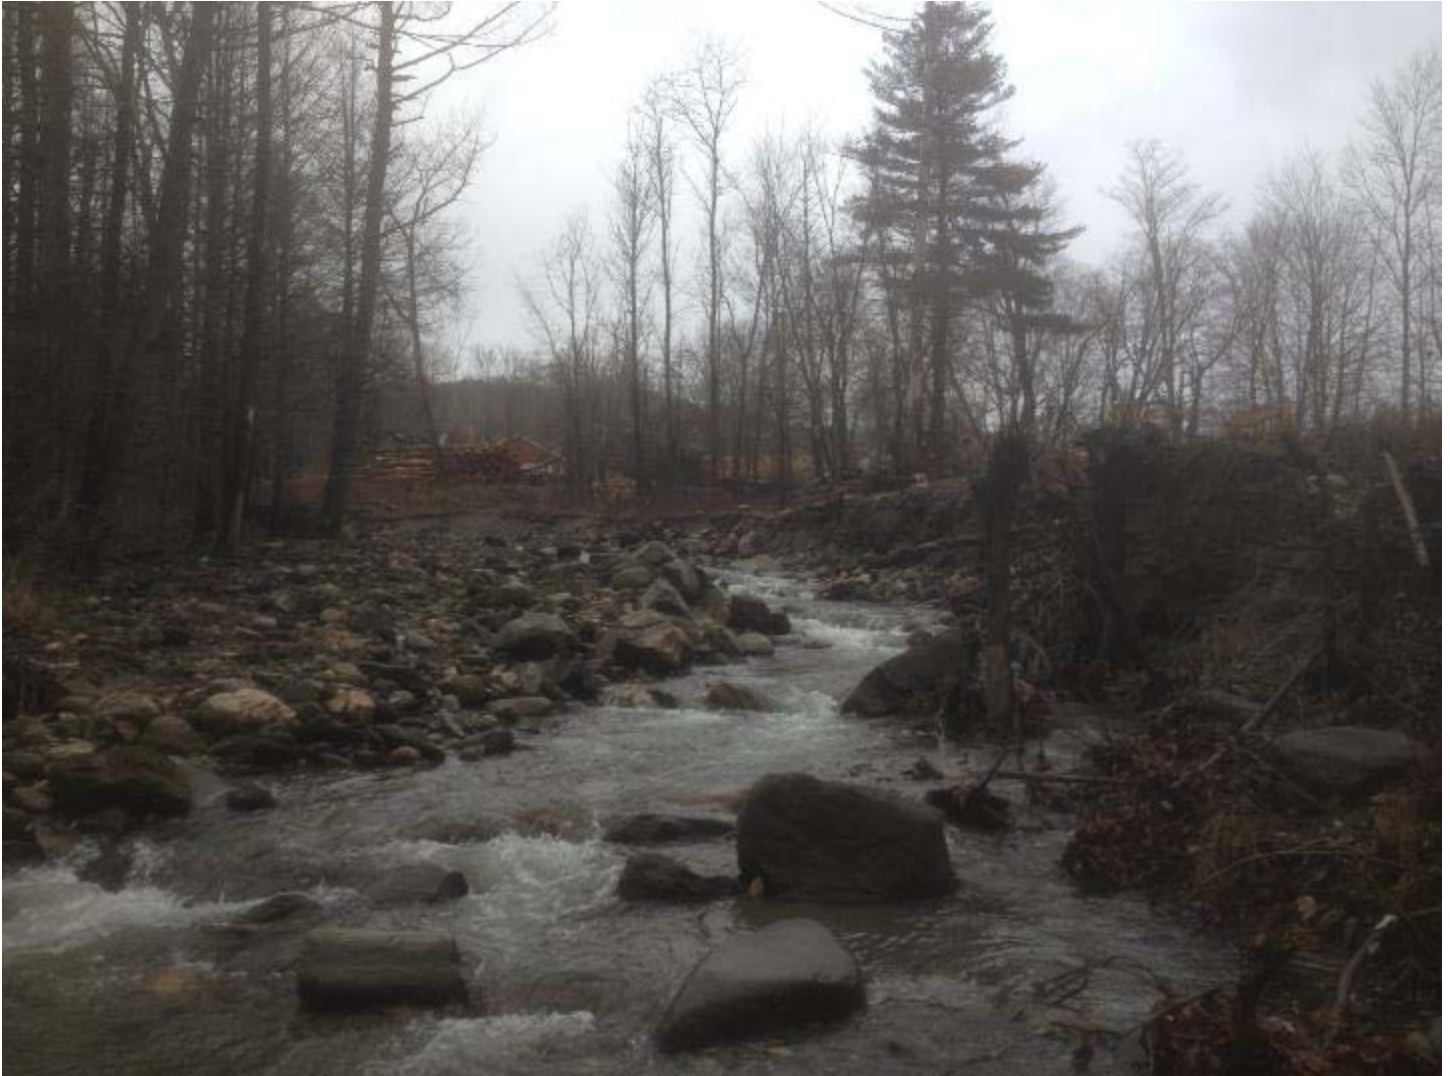
Top: Upstream end of culvert

Bottom: Stream out of equilibrium upstream from the undersized culvert. Majority of the debris and damage due to heavy water flows during Tropical Storm Irene.

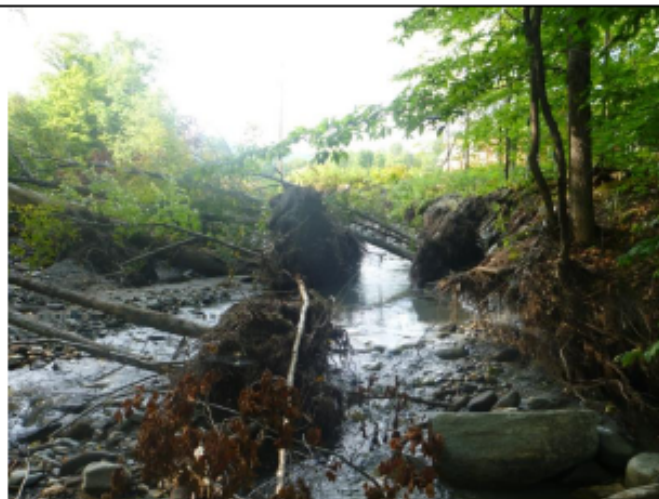
Widening, deposition, and severe erosion

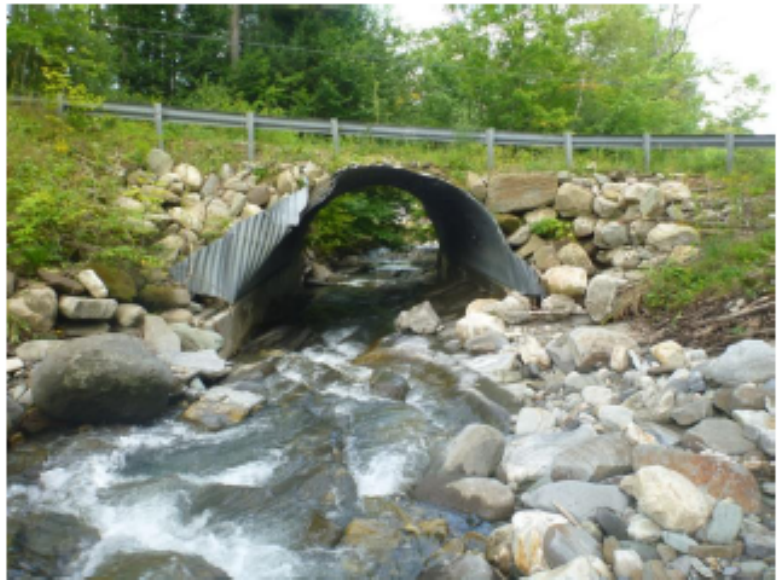
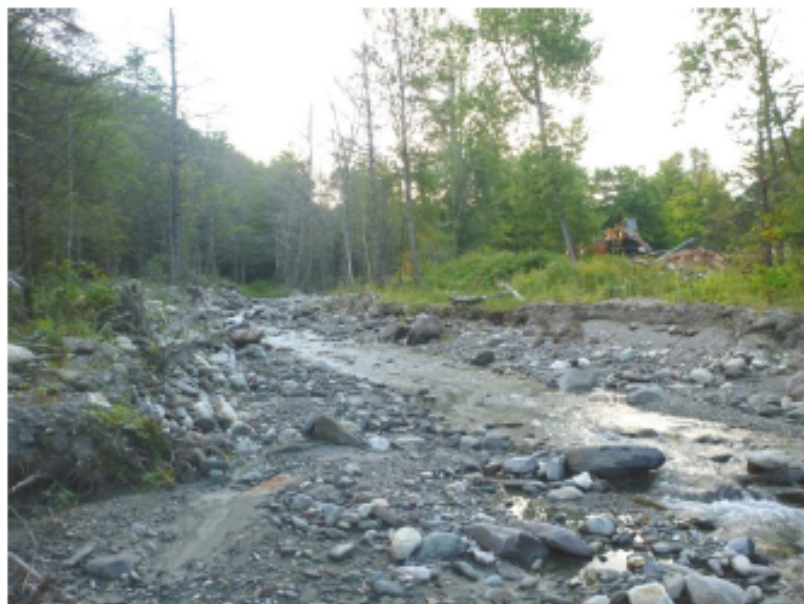
Projects RE 20 and RE 21 – Bailey Brook Alluvial Fan Restoration and Flood Mitigation

Bailey Brook flows out of steep, mountainous terrain and reaches a significant transition point near the intersection of Baileys Mills Road and Town Farm Road. At this point (Segment T4.01.A), the slope of the river decreases and the river valley widens. In geologic terms, this area is referred to as an “alluvial fan,” where the sediment and debris carried by the brook settles out across the valley. Exacerbating this natural deposition process is a bridge-arch structure underneath Baileys Mills Road that is undersized for the channel. The post-Irene channel width varies between 40 and 50 feet in segment T4.01.A, while the arch width is only 19 feet. During Tropical Storm Irene flooding, tremendous amounts of sediment and debris generated from upstream mass failures along Bailey Brook were deposited over this alluvial fan. The debris field extended over 1,000 feet upstream along Bailey Brook and Town Farm Road. The channel is actively carving and braiding through these deposits. Many of the trees within the pine/hemlock floodplain forest along Town Hill Road are dead due to girdling from flood sediments. Berms are disconnecting the floodplain in one location, and bank erosion is severe throughout.

Given the severe instability of the upstream banks and valley walls, and the amount of sediment and debris in the river corridor waiting to be carried down to the alluvial fan in the next flood, we expect the degree of risk and conflict at this site to worsen during future floods. We recommend that the Town

complete an alternatives analysis to evaluate options for alluvial fan management. Options may include: 1) Replace arch with a larger structure to maximize capacity over the bedrock grade control; 2) Road or intersection realignment to southwest to accommodate alluvial fan flooding; 3) Berm removal, dead tree removal, and re-vegetation of the floodplain along Town Farm Road. With any of these alternatives, local flood hydraulics and sediment transport will need to be analyzed carefully to ensure that risks to downstream property are not increased. If this area has experienced repeat flood damage, it may be eligible

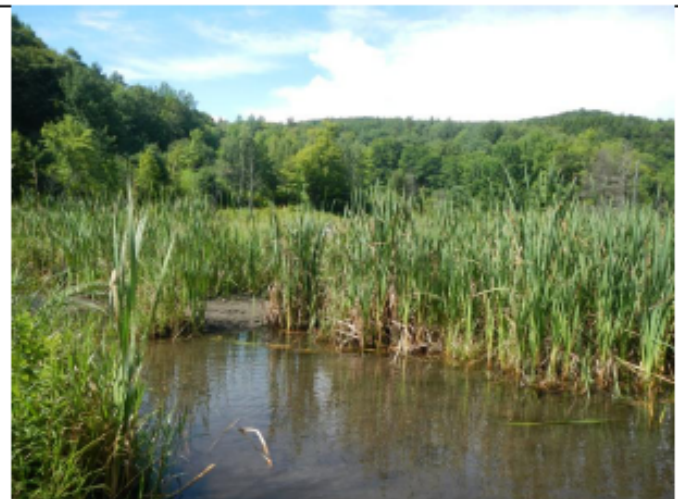
Large beaver dam in upper reach

Multi-thread channel through a beaver meadow

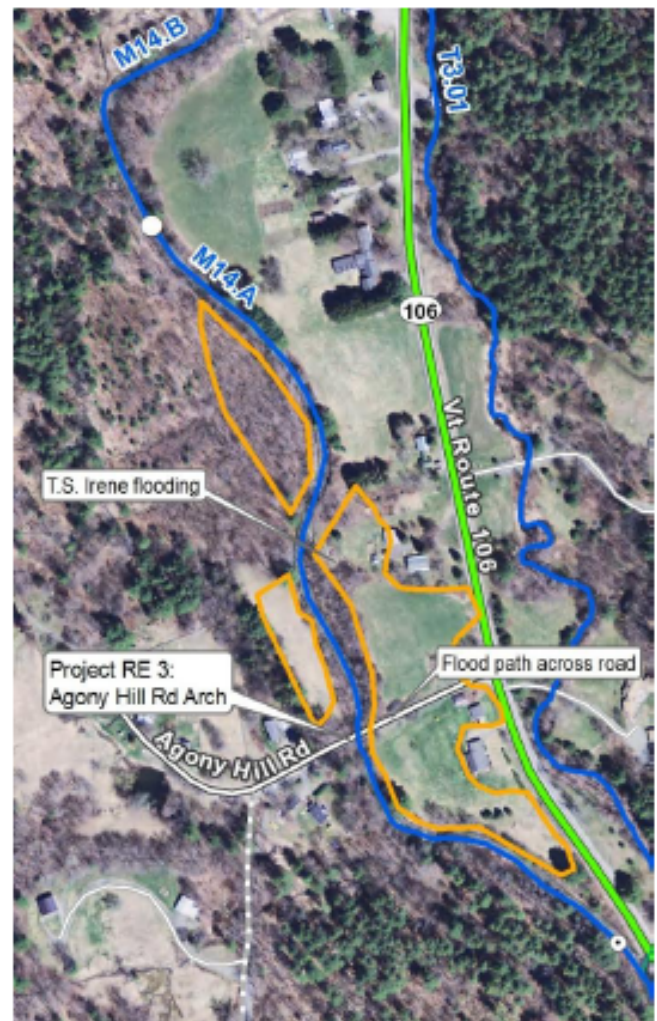
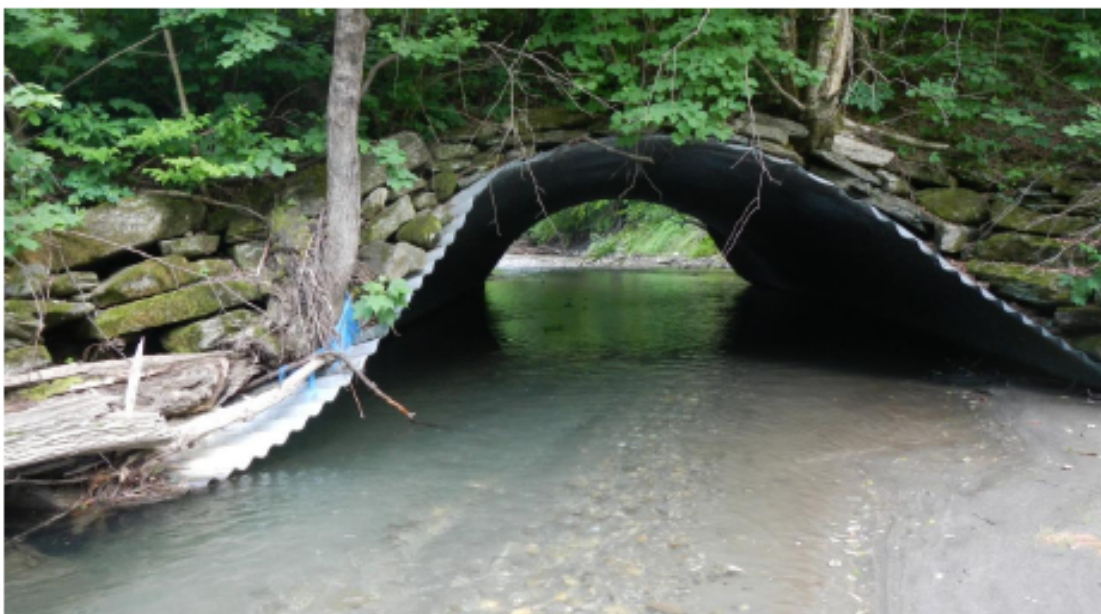
Undersized arch and downstream mass failure

The steel arch under Agony Hill Road is a channel constriction (70% of bankfull width), poorly aligned, deformed, and filling in with sediment. The arch is located near the middle of segment M14.A which was likely historically straightened and incised. During T.S. Irene the channel widened dramatically and began to redevelop some meander bends. Overbank flooding deposited large volumes of sand and gravel over the forested right floodplain areas (orange areas in map to right) and buried three properties along the left bank. A low section of road bed along Agony Hill Rd served as a valuable flood relief area and likely reduced damage to the upstream properties. The channel remains highly active and continues to widen and adjust planform. Huge volumes of flood sediments are working through the segment, creating large bar features.

We recommend replacing the arch with a larger structure to better accommodate the large volumes of sediment working through the reach. A structure larger than the predicted bankfull channel width (36 feet) should be considered based on channel adjustment processes (Schiff *et al.*, 2014). The floodplain spillway over the road should be stabilized but not elevated. Additional projects to protect floodplain (RE 4) and stabilize and plant an eroding bank (RE 1d) should be considered for implementation before or during any structure replacement. VTrans and the Town of Reading are potential partners for this project.

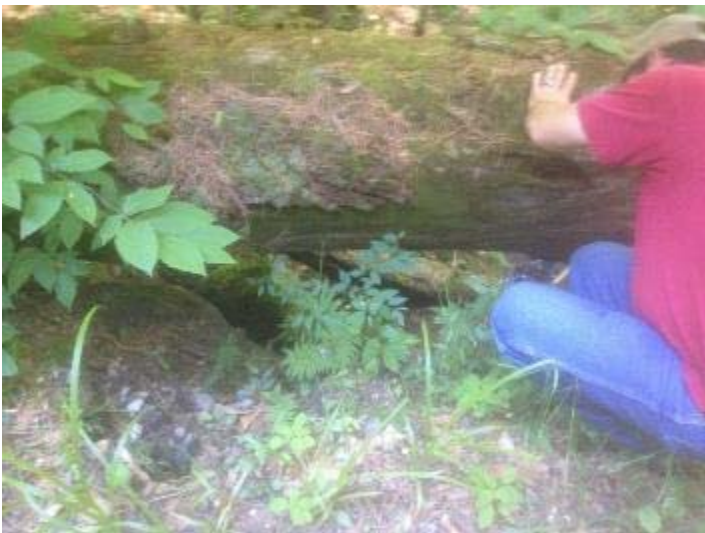
Top left: Class 4 roadway shows signs of erosion at the edge of a steep bank

The solutions and costs are to be determined if bank destabilizes. This site is a very low priority since the slope has been stable for a long time, there is now stream at the base of the slope and is on a class 4 town highway. Town does not grade this road.

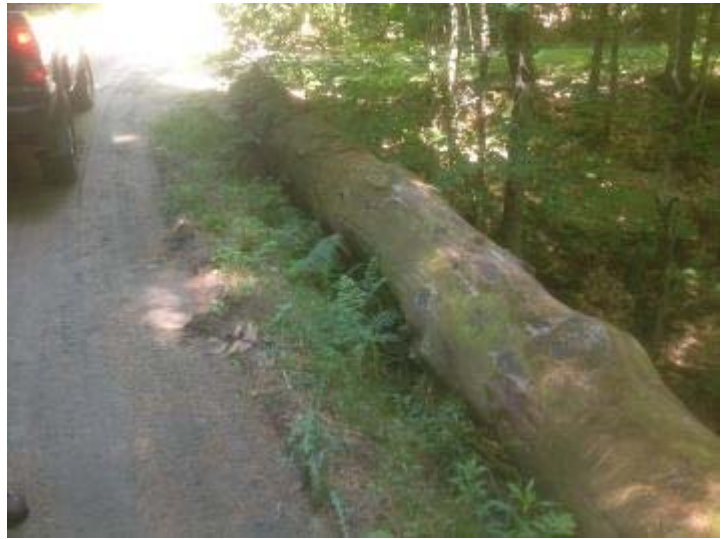
Top right: Large log just beyond edge of roadway, shielding the steep slope

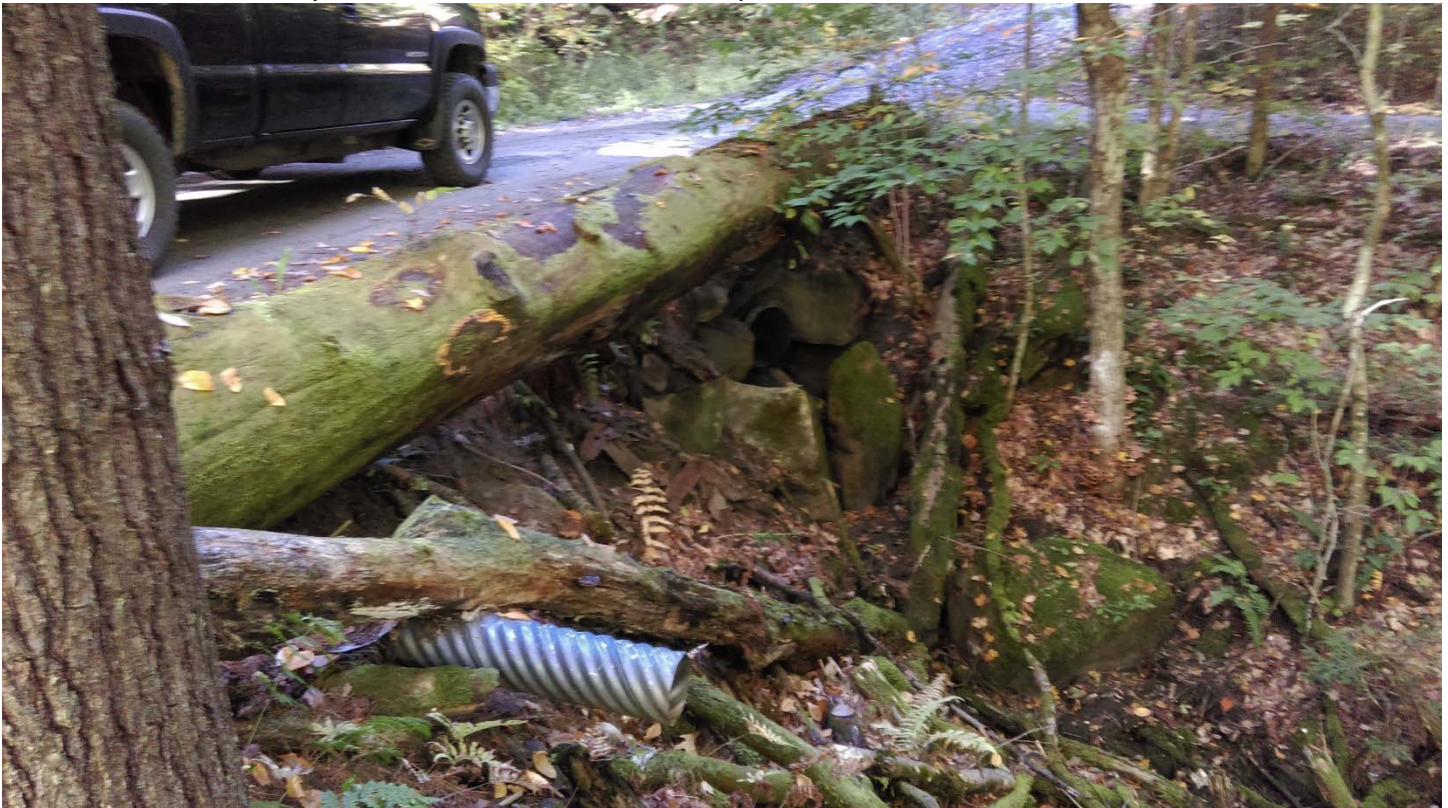
Bottom: Class 4 roadway as seen from the side of the slope.

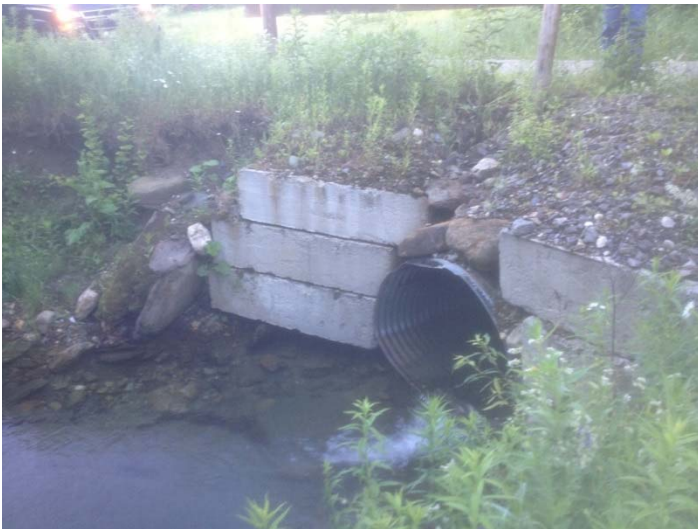
A large culvert on Brown Schoolhouse Road which conveys a perennial stream is failing – bottom is starting to rust and get holes, there is serious undercutting around the downstream end of the culvert, and part of the cover above the culvert is destabilizing at the edge of the roadway. Between visiting the site in late June and early August the edge of the roadway destabilized considerably.

Bottom left: More cover above the culvert when visiting 5 weeks earlier – June 30, 2016.

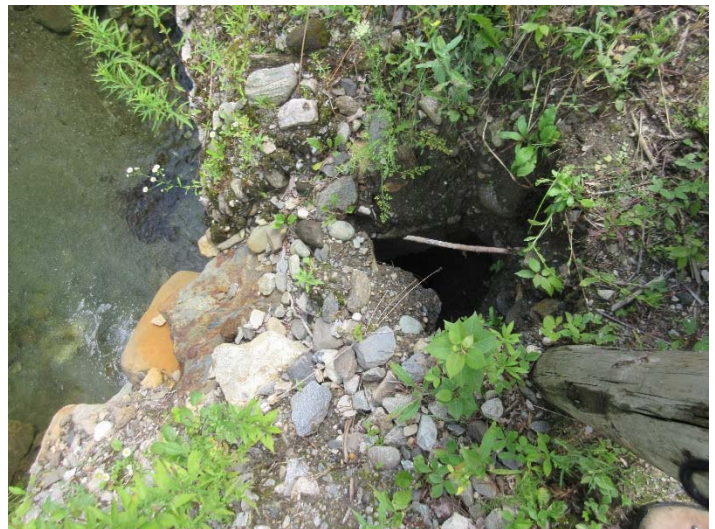
Bottom right: Looking down on destabilized culvert cover. August 2, 2016

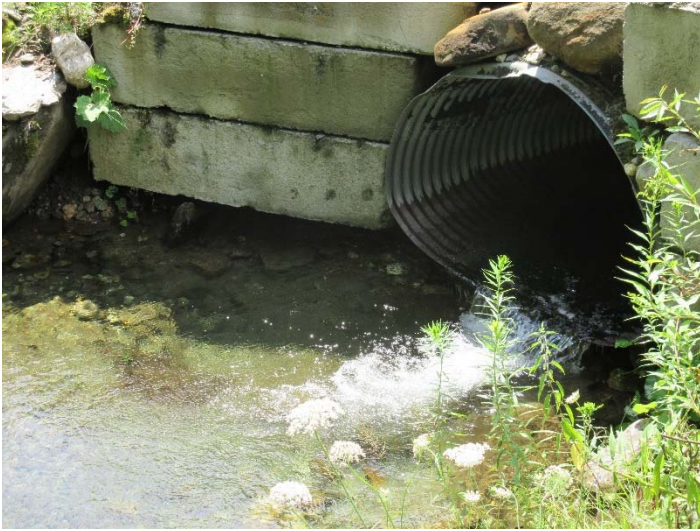
Top left: Undercutting of culvert and headers.

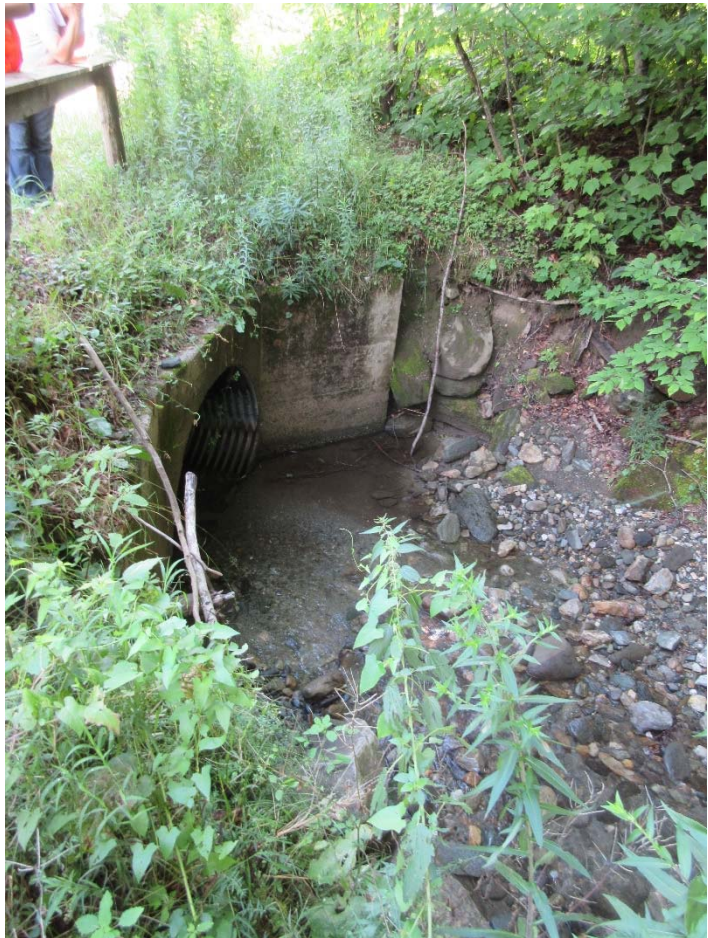
Top right: Upstream end of culvert with concrete headers.

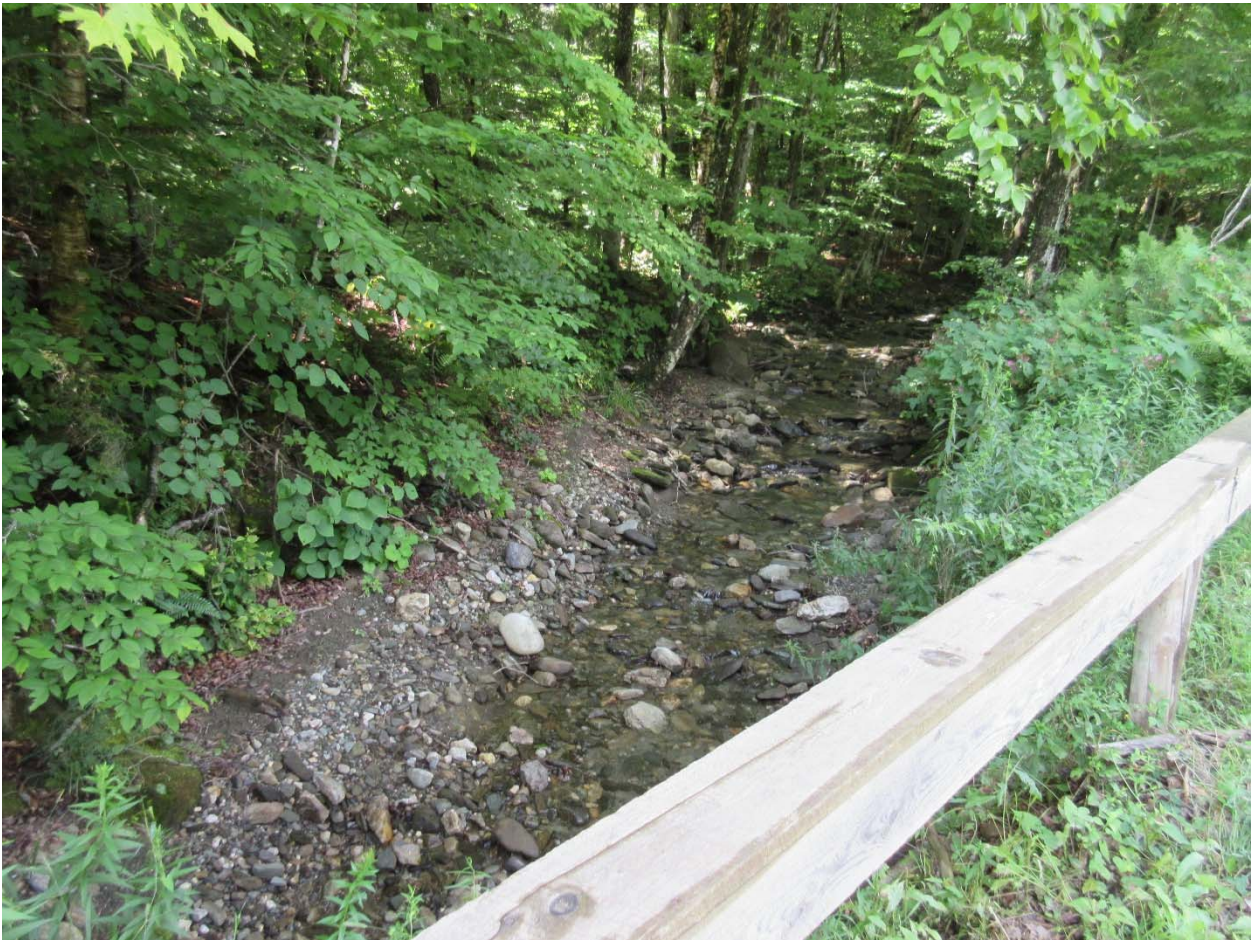
Bottom right: Looking upstream from the culvert.
