Town of Reading Road Erosion Inventory 2016

Completed by Southern Windsor County Regional Planning Commission and the Town of Reading

Fieldwork completed June/ July 2016
Report last revised December 12, 2016

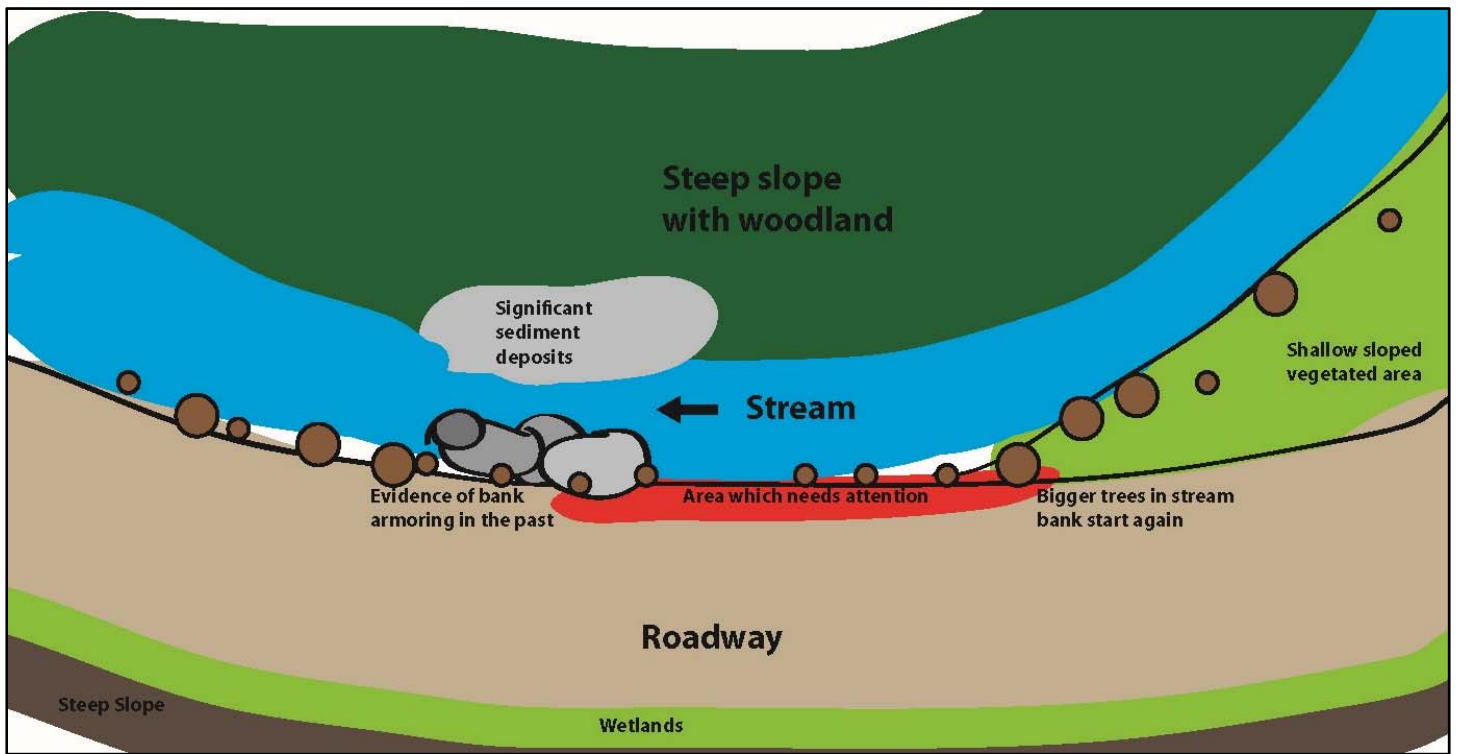
Site Sketch

Stream runs very close to the roadway. The stream bank is already beginning to fail along the roadway at a corner of the stream where there are insufficient trees and/or stone on the bank. The issue is being caused by the movement of the stream (the corner is slowly moving upstream) rather than the roadway. The stream will likely undercut the roadway if the bank is not stabilized or the road moved away from the edge of the stream.

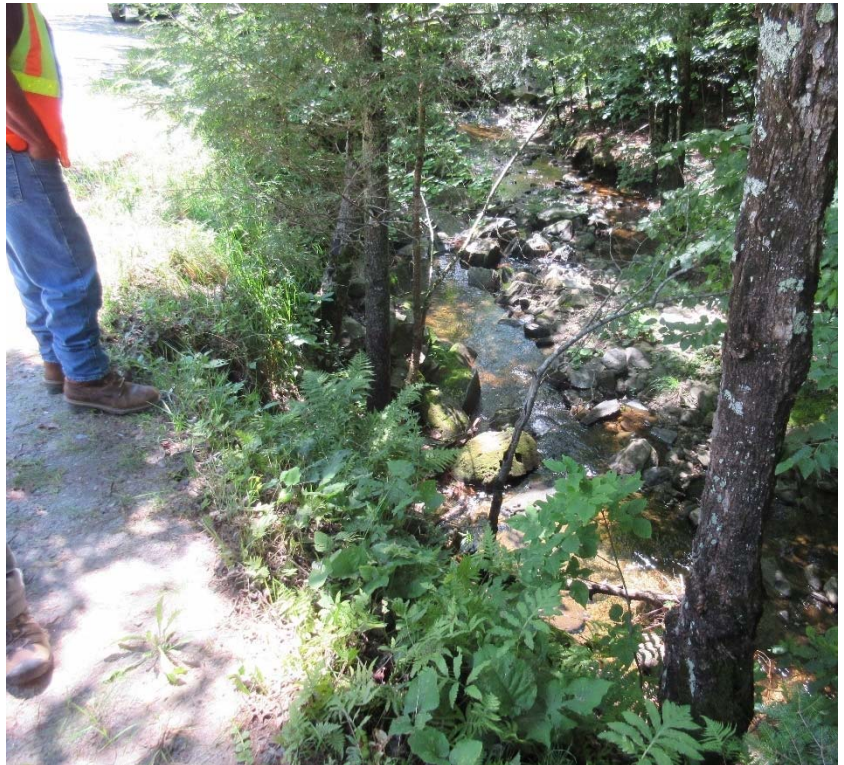
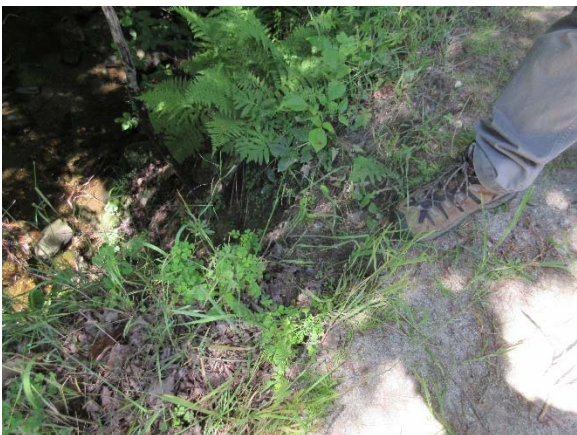
All: Bank destabilizing where trees stop.

Right and Bottom: Major destabilization next to person's boot

Top and Bottom:
Stream
curve next
to roadway.
Areas with
bigger trees
are holding
well. Areas
with smaller
trees or no
trees are
unstable.
